SIEVE ANALYSIS - JUPITER ISLAND 10.GPJ FL DEP ROSS.GDT 6/26/10

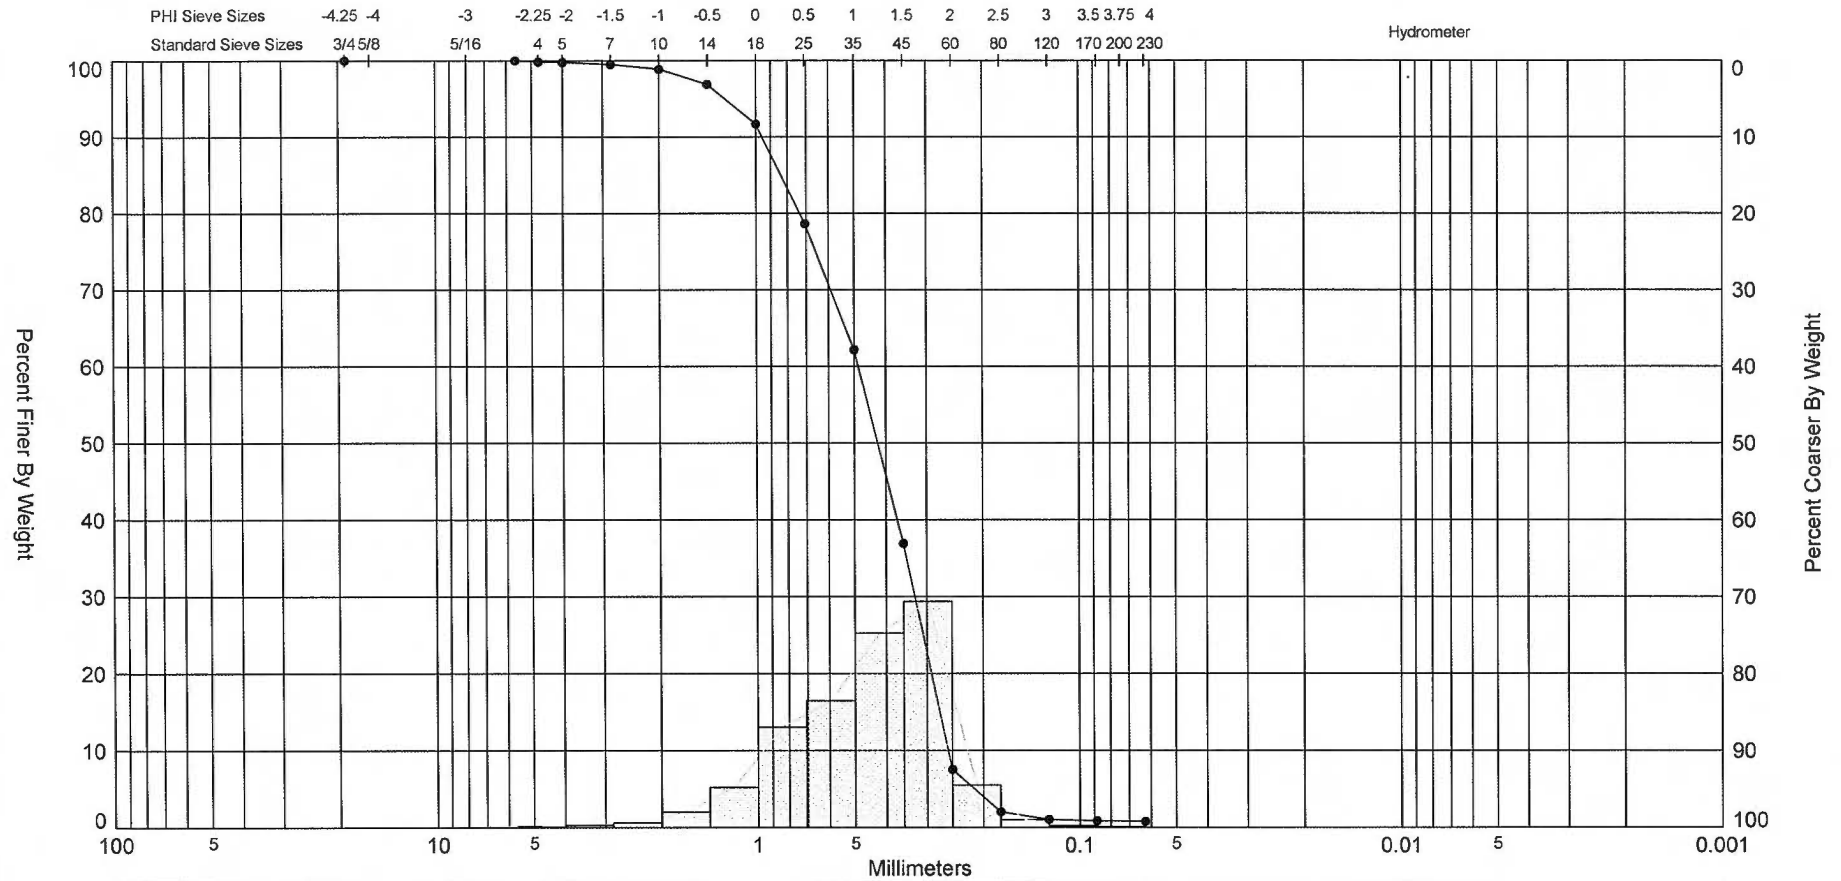
Sample	Symbol	Elev. (ft)	USCS	% Fines	% Organics	% Carbonates	Median	Mean	Skew	Kurt	Sort	Sample Information	
JI-10 #S-1 (2.5')	—●—	-45.4	SP	#230 - 0.75			1.24	1.11	-0.74	3.97	0.78	Project Name:	Jupiter Island 10
Comments: 10YR 4/1 Munsell @ 10% Moisture												Analysis Date:	03-29-10
Depths and elevations based on measured values												Analyzed By:	JR

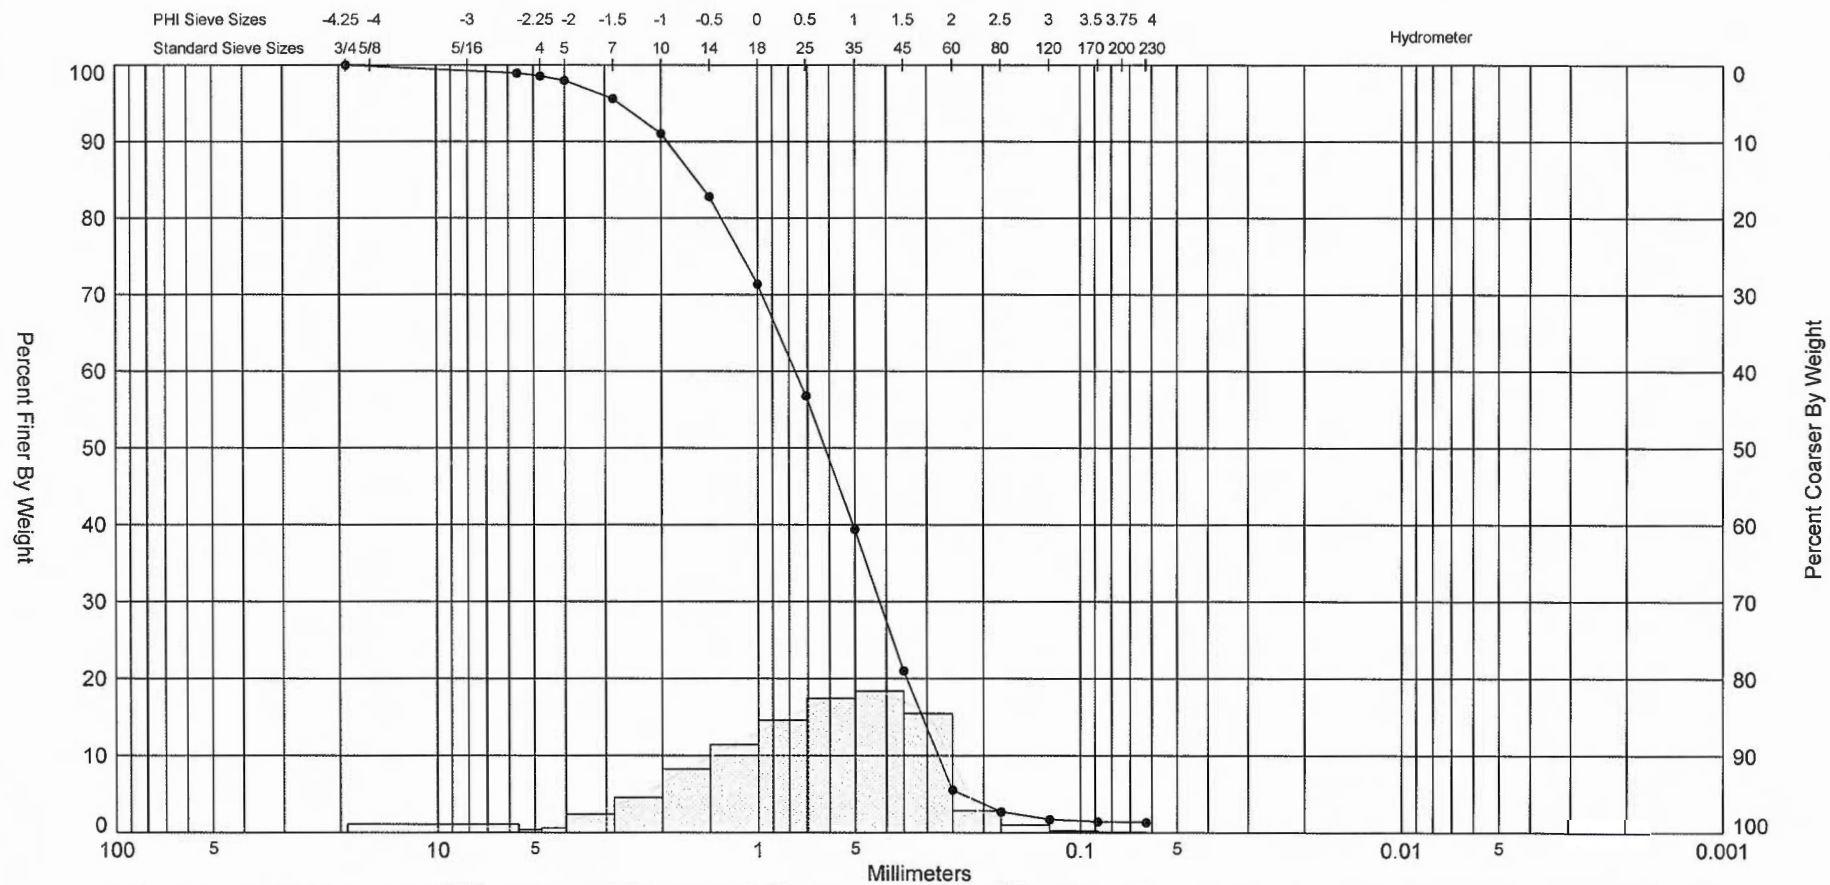
Sample	Symbol	Elev. (ft)	USCS	% Fines	% Organics	% Carbonates	Median	Mean	Skew	Kurt	Sort	Sample Information	
JI-10 #S-2 (6.6')	—●—	-49.5	SW	#230 - 1.32		86.80	0.69	0.53	-0.68	3.71	1.11	Project Name:	Jupiter Island 10
Comments: 10 YR 5/1 Munsell @ 10% Moisture												Analysis Date:	04-23-10
Depths and elevations based on measured values												Analyzed By:	JR

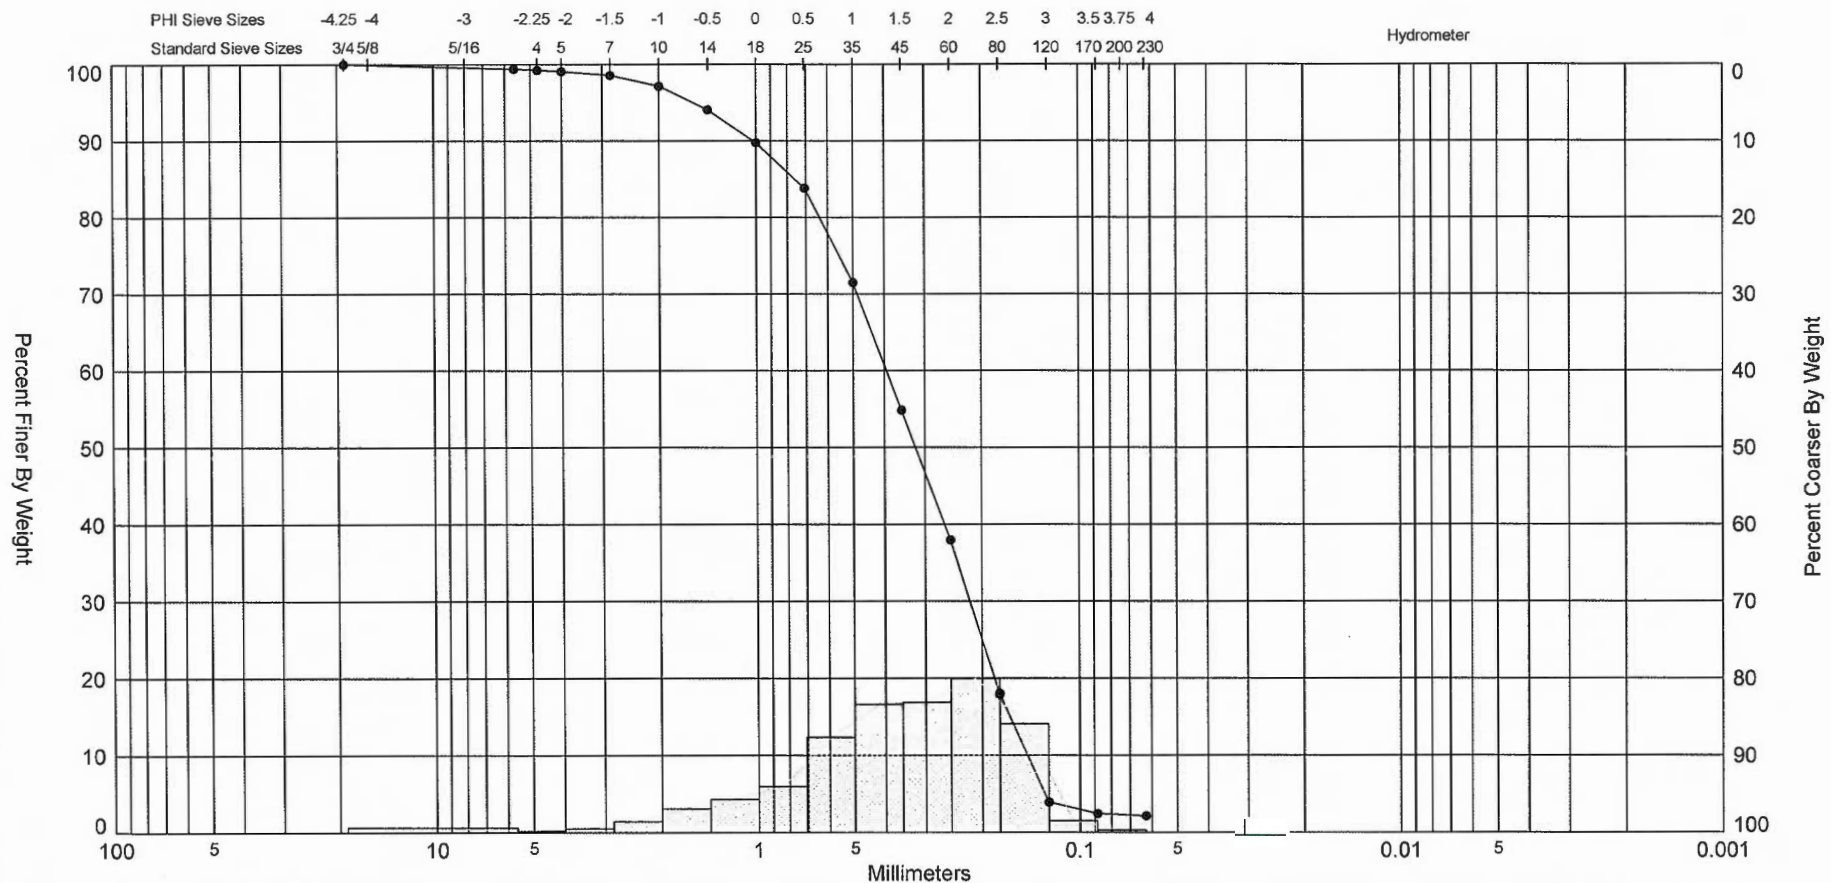
Sample	Symbol	Elev. (ft)	USCS	% Fines	% Organics	% Carbonates	Median	Mean	Skew	Kurt	Sort	Sample Information	
Jl-10 #S-3 (9.5')	—●—	-52.4	SW	#230 - 2.13		72.90	1.64	1.45	-1.07	4.75	1.11	Project Name:	Jupiter Island 10
Comments: 10YR 4/1 Munsell @ 10% Moisture												Analysis Date:	03-31-10
Depths and elevations based on measured values												Analyzed By:	JR

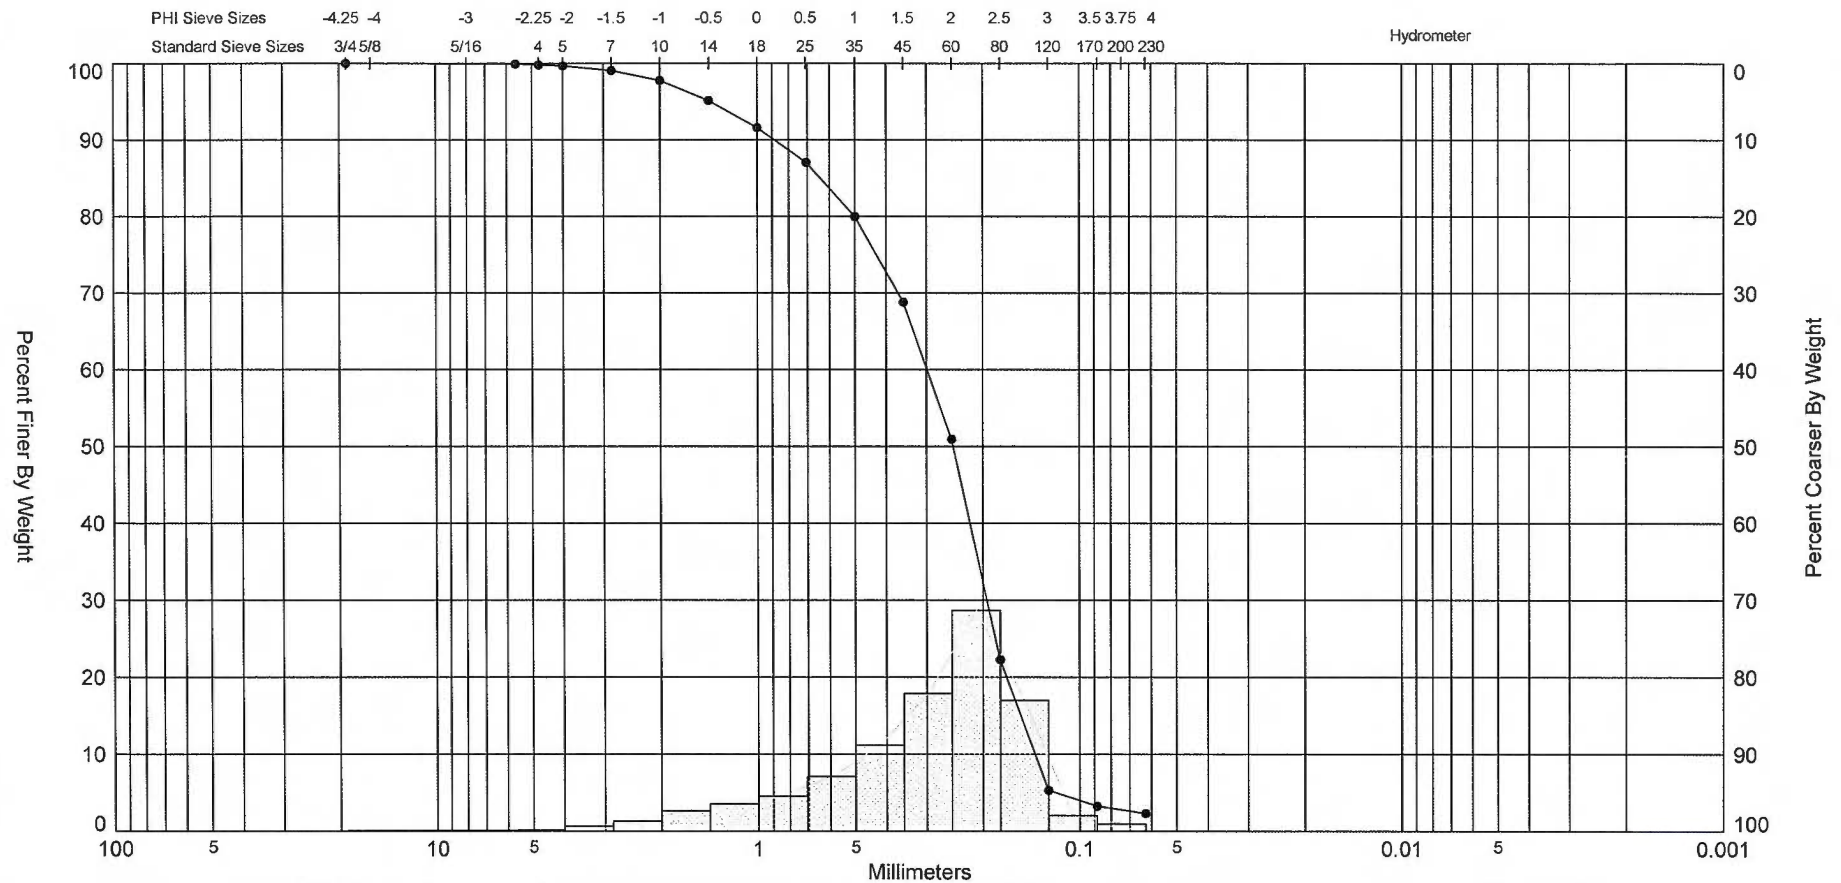
Sample	Symbol	Elev. (ft)	USCS	% Fines	% Organics	% Carbonates	Median	Mean	Skew	Kurt	Sort	Sample Information	
Jl-10 #S-4 (13)	—●—	-55.9	SP	#230 - 2.31			2.02	1.71	-1.16	4.39	1.05	Project Name:	Jupiter Island 10
Comments: 10YR 4/1 @ 10% moisture												Analysis Date:	03-31-10
Depths and elevations based on measured values												Analyzed By:	JR

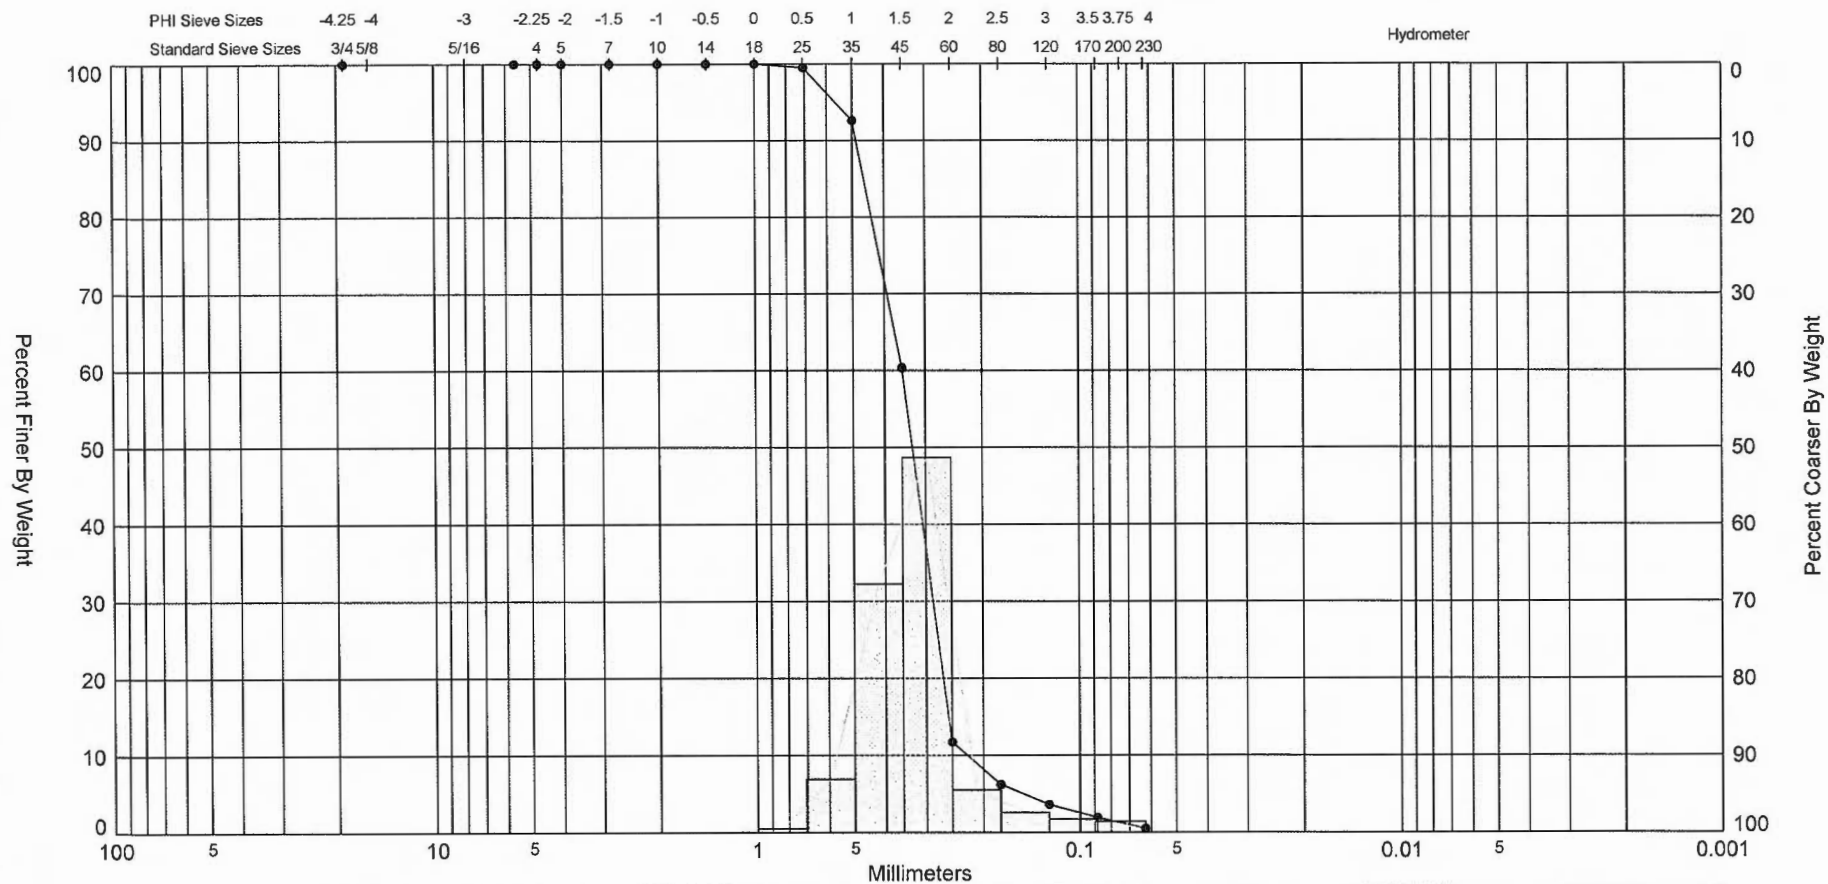
Sample	Symbol	Elev. (ft)	USCS	% Fines	% Organics	% Carbonates	Median	Mean	Skew	Kurt	Sort	Sample Information	
Jl-10 PCC #S-1 (6.6')	—●—	-49.5	SP	#230 - 0.50			1.61	1.62	1.28	6.75	0.53	Project Name:	Jupiter Island 10
Comments: 10 YR 5/1 Munsell @ 10% moisture. Sample after Calcium carbonate.											Analysis Date:	02-23-10	
Depths and elevations based on measured values											Analyzed By:	ML
