SIEVE ANALYSIS JUPITER ISLAND 10.GPJ FL DEP ROSS.GDT 6/26/10

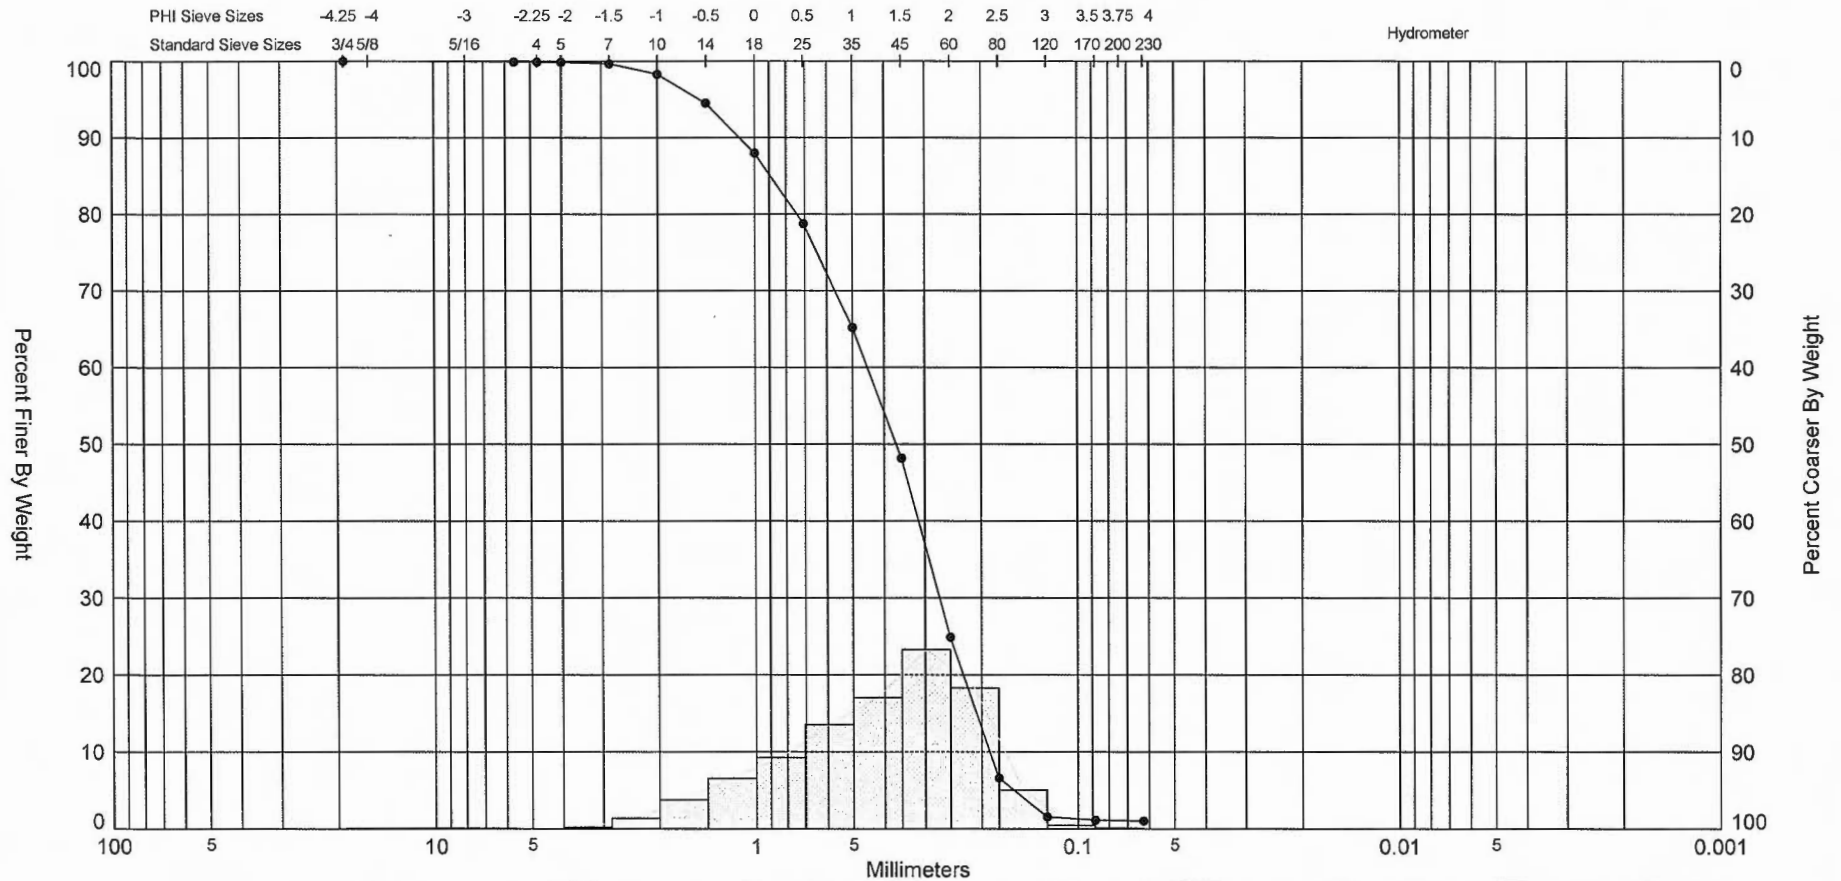
Gravel		Sand			Silt and Clay
Coarse	Fine	Coarse	Medium	Fine

Sample	Symbol	Elev. (ft)	USCS	% Fines	% Organics	% Carbonates	Median	Mean	Skew	Kurt	Sort	Sample Information	
Jl-28 #S-1 (2')	—●—	-54.7	SW	#230 - 1.01			1.45	1.26	-0.66	3.22	0.97	Project Name:	Jupiter Island 10
Comments: 10 YR 4/1 Munsell @ 10% Moisture												Analysis Date:	04-22-10
Depths and elevations based on measured values												Analyzed By:	ML

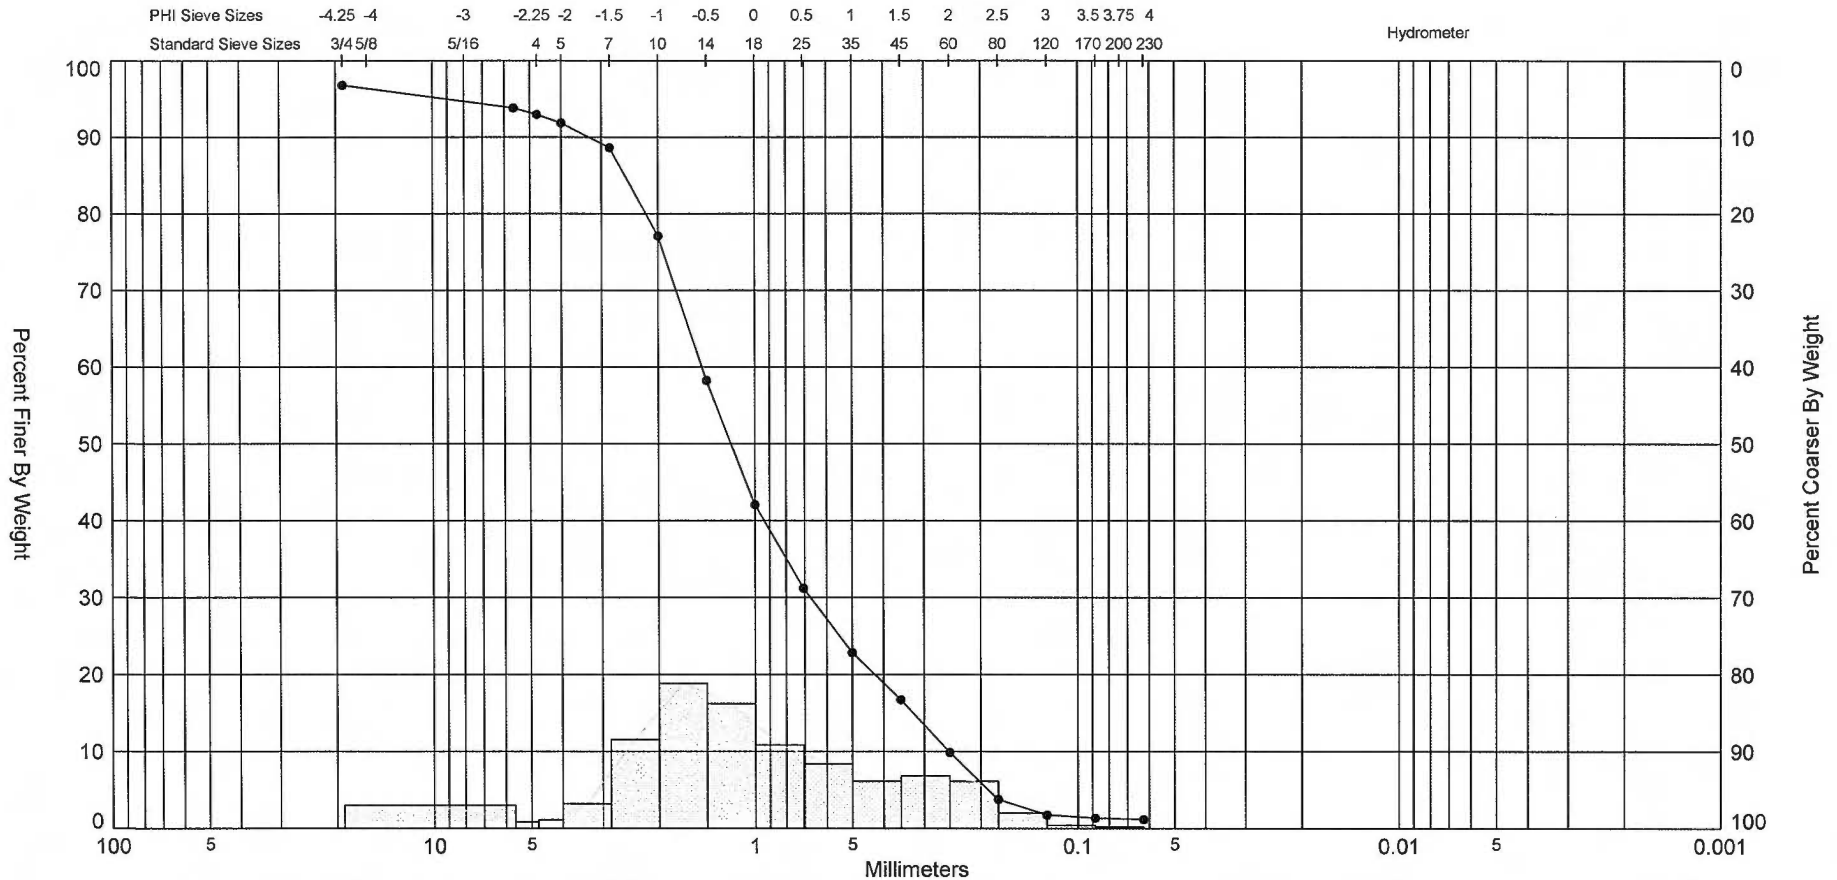
Gravel		Sand			Silt and Clay
Coarse	Fine	Coarse	Medium	Fine

Sample	Symbol	Elev. (ft)	USCS	% Fines	% Organics	% Carbonates	Median	Mean	Skew	Kurt	Sort	Sample Information	
Jl-28 #S-2 (3.4')	—●—	-56.1	SW	#230 - 1.15		88.50		-0.19	0.45	3.16	1.33	Project Name:	Jupiter Island 10
Comments: 10 YR 5/1 Munsell @ 10% Moisture												Analysis Date:	04-22-10
Depths and elevations based on measured values												Analyzed By:	ML

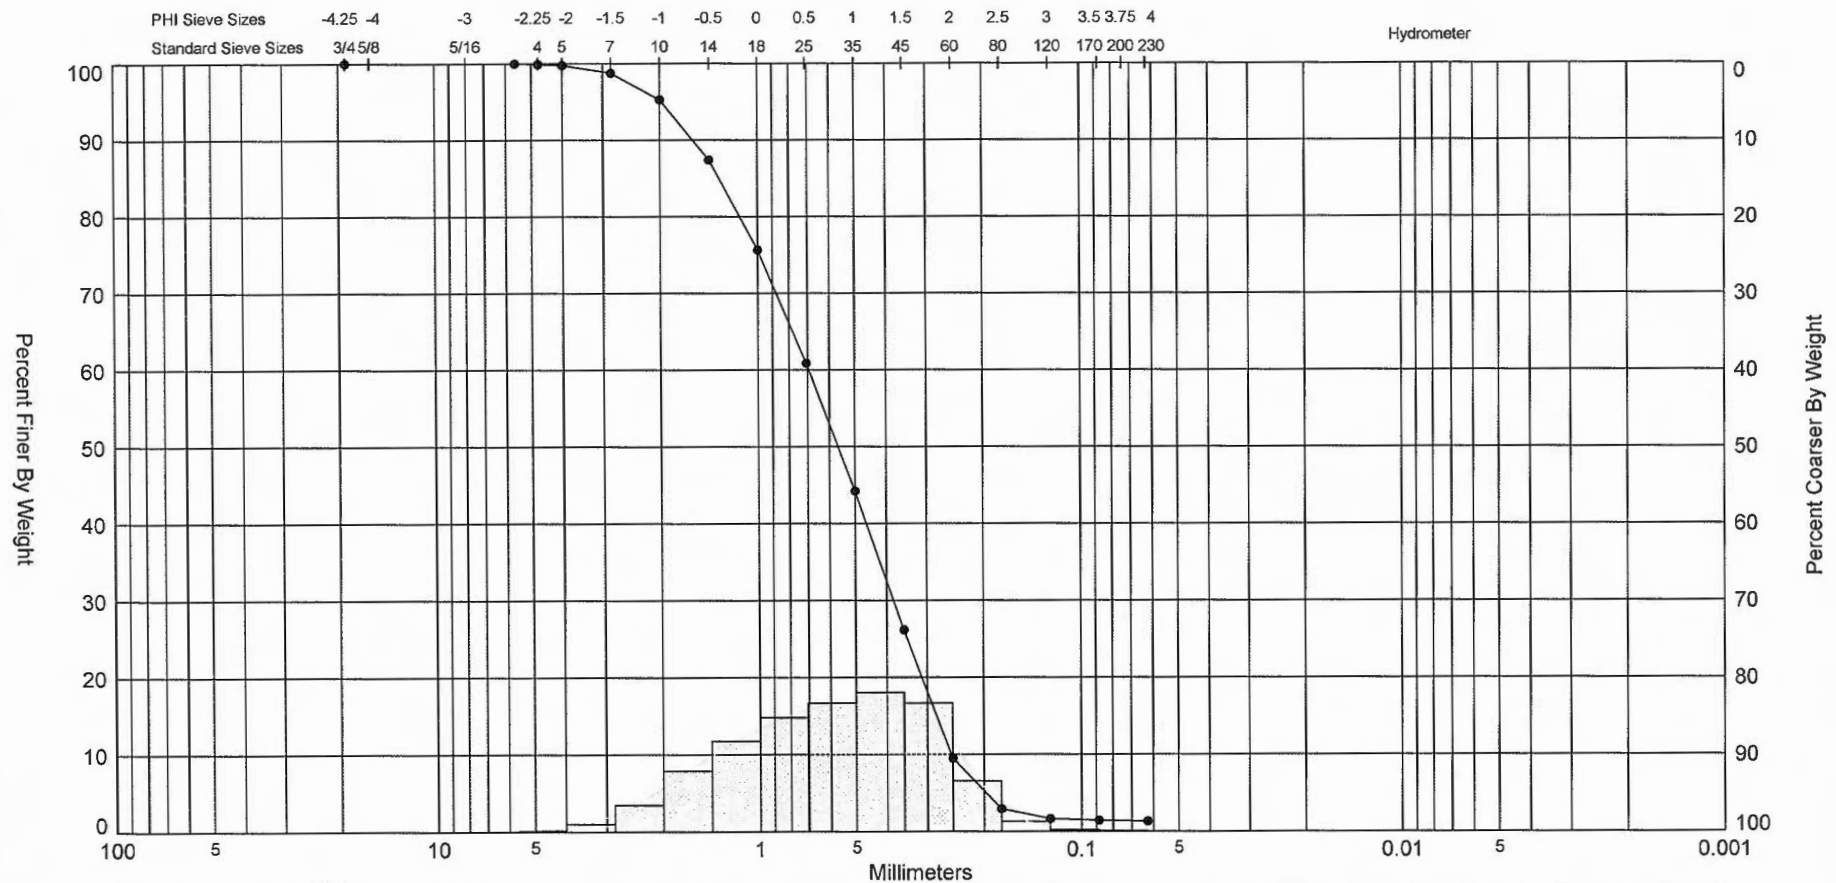
Gravel		Sand			Silt and Clay
Coarse	Fine	Coarse	Medium	Fine

Sample	Symbol	Elev. (ft)	USCS	% Fines	% Organics	% Carbonates	Median	Mean	Skew	Kurt	Sort	Sample Information	
JI-28 #S-3 (6.3')	—●—	-59.0	SW	#230 - 1.31		78.50	0.83	0.73	-0.26	2.54	1	Project Name:	Jupiter Island 10
Comments: 10 YR 5/1 Munsell @ 10% Moisture												Analysis Date:	04-24-10
Depths and elevations based on measured values												Analyzed By:	JR
<div style="display: flex; justify-content: space-between; align-items: center;"> <div style="text-align: center;">

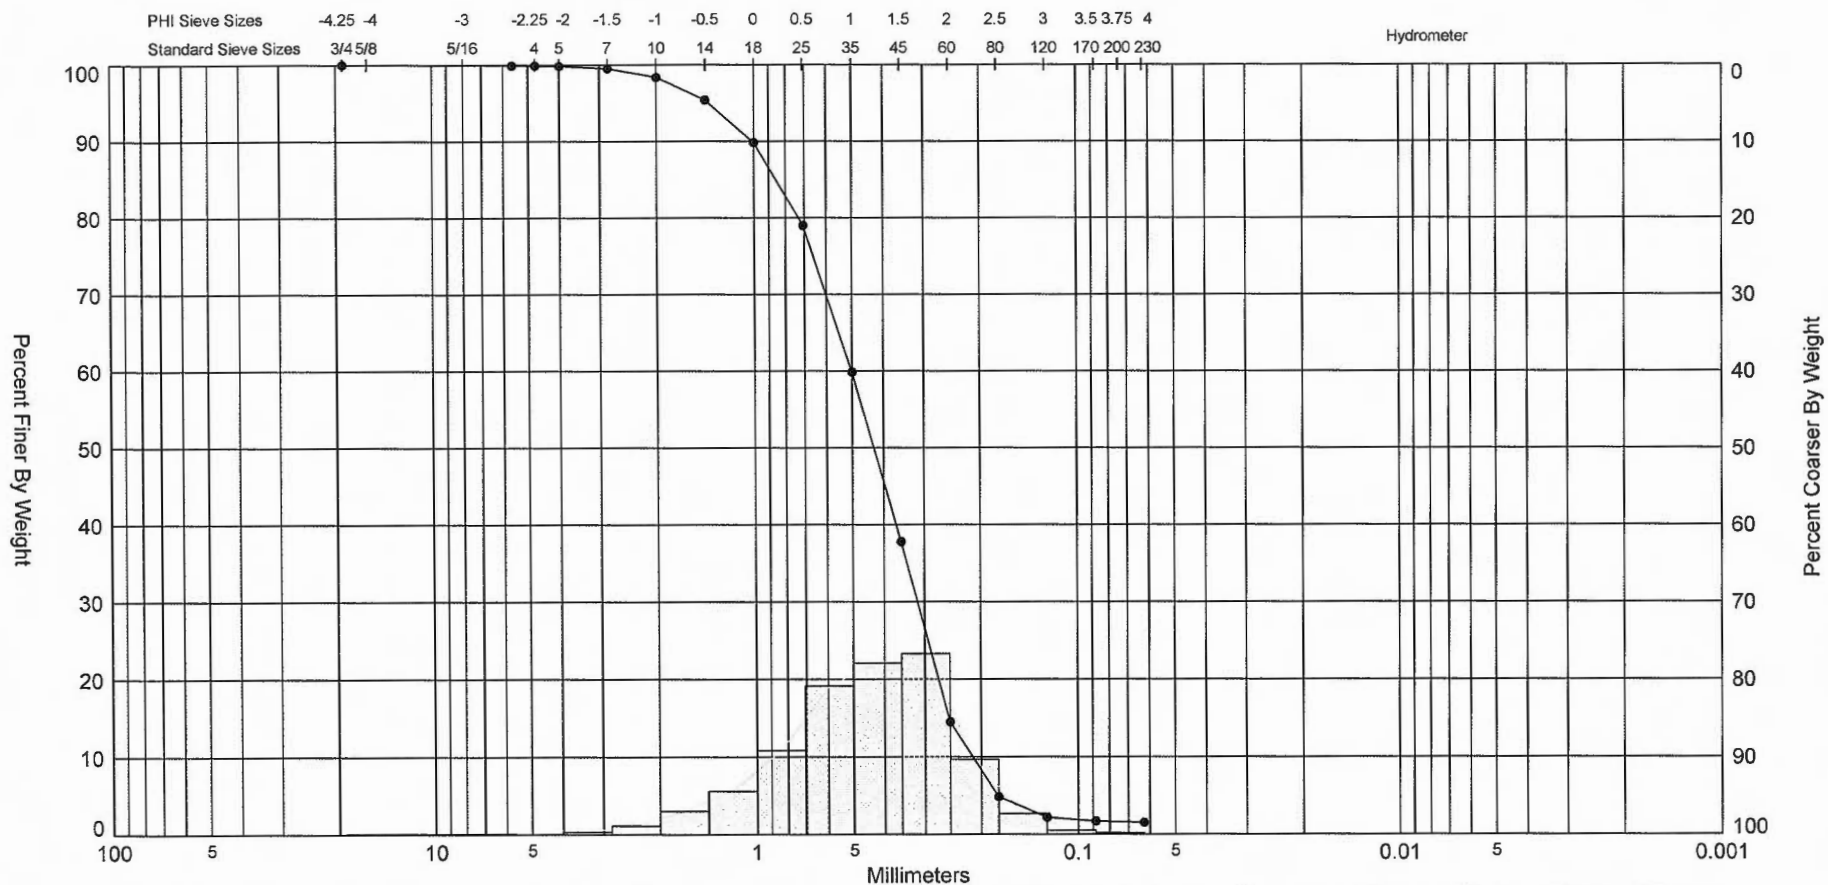
Gravel		Sand			Silt and Clay
Coarse	Fine	Coarse	Medium	Fine

Sample	Symbol	Elev. (ft)	USCS	% Fines	% Organics	% Carbonates	Median	Mean	Skew	Kurt	Sort	Sample Information	
JI-28 #S-4 (9')	—●—	-61.7	SW	#230 - 1.51			1.22	1.12	-0.56	3.85	0.88	Project Name:	Jupiter Island 10
Comments: 10 YR 4/1 Munsell @ 10% Moisture												Analysis Date:	04-22-10
Depths and elevations based on measured values												Analyzed By:	ML

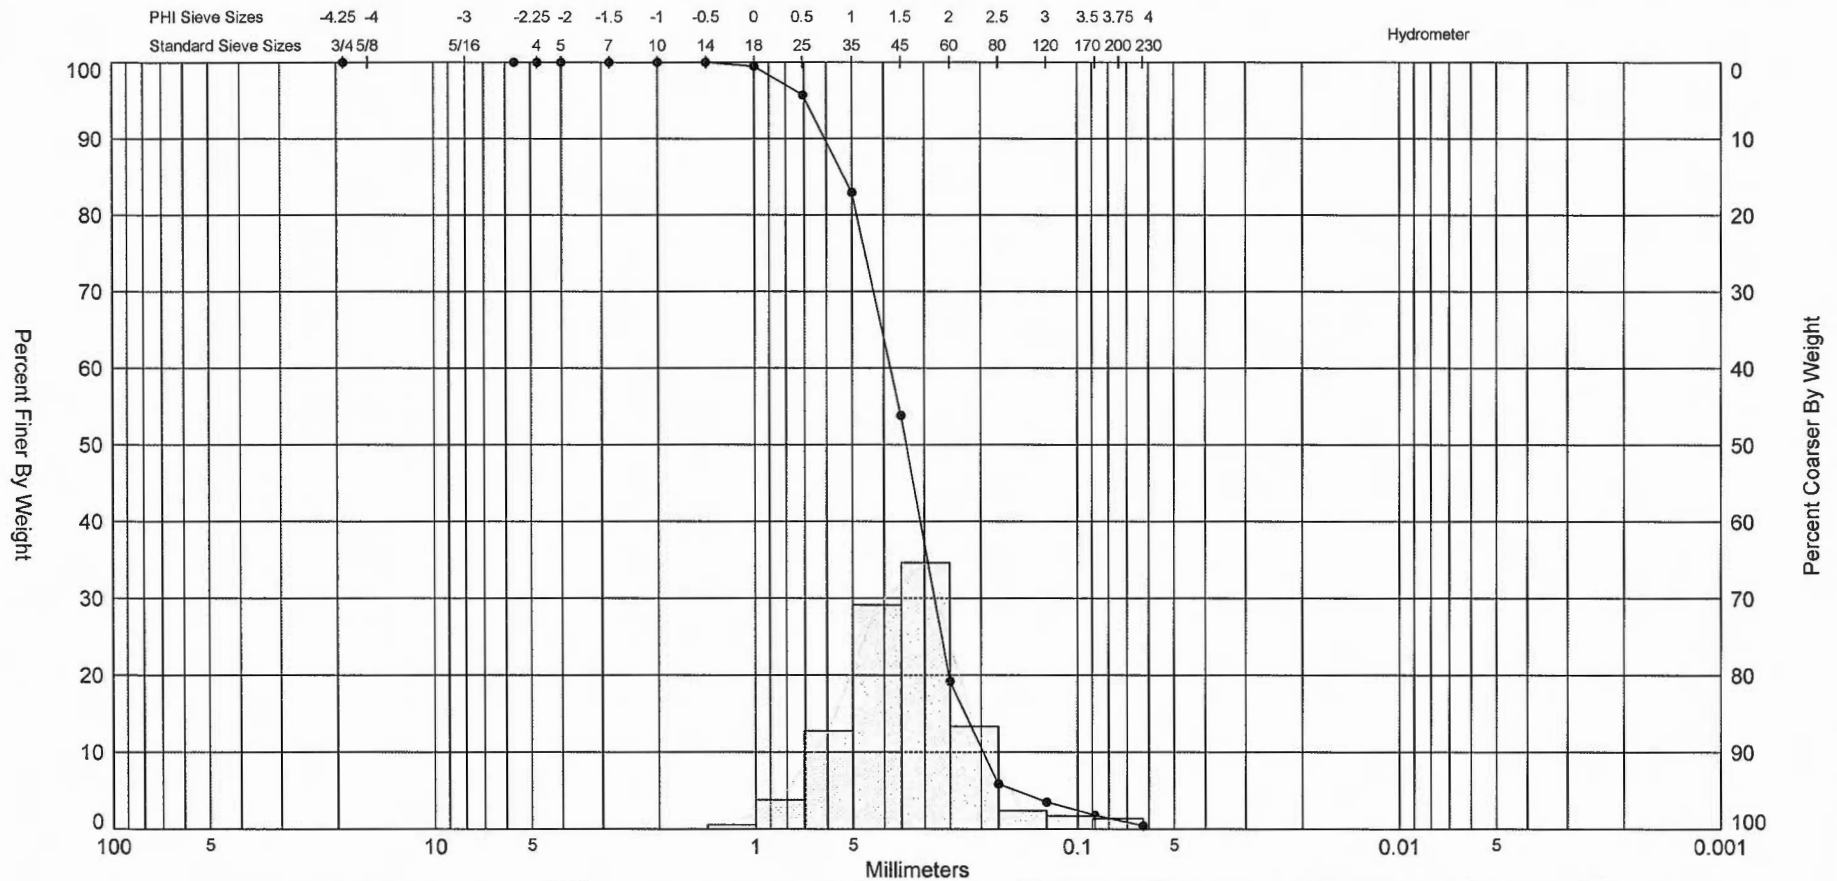
Gravel		Sand			Silt and Clay
Coarse	Fine	Coarse	Medium	Fine

Sample	Symbol	Elev. (ft)	USCS	% Fines	% Organics	% Carbonates	Median	Mean	Skew	Kurt	Sort	Sample Information	
JL-28 PCC #S-1 (6.3')	—●—	-59.0	SP	#230 - 0.42			1.56	1.55	0.48	4.34	0.65	Project Name:	Jupiter Island 10
Comments: 10 YR 5/1 Munsell @ 10% moisture. Sample after calcium carbonate.												Analysis Date:	02-23-10
Depths and elevations based on measured values												Analyzed By:	ML
