SIEVE ANALYSIS SIESTA KEY 2,27-14.GPJ FL DEP ROSS.GDT 2/27/14

Athena Technologies, Inc. 1293 Graham Farm Road McClellanville, SC 29458 ph (843) 887-3800 fax (843) 887-3801					Easting (X, ft):	438,657
												Northing (Y, ft):	1,028,523
												Horizontal System:	NAD 1983
												Vertical System:	NAVD 88

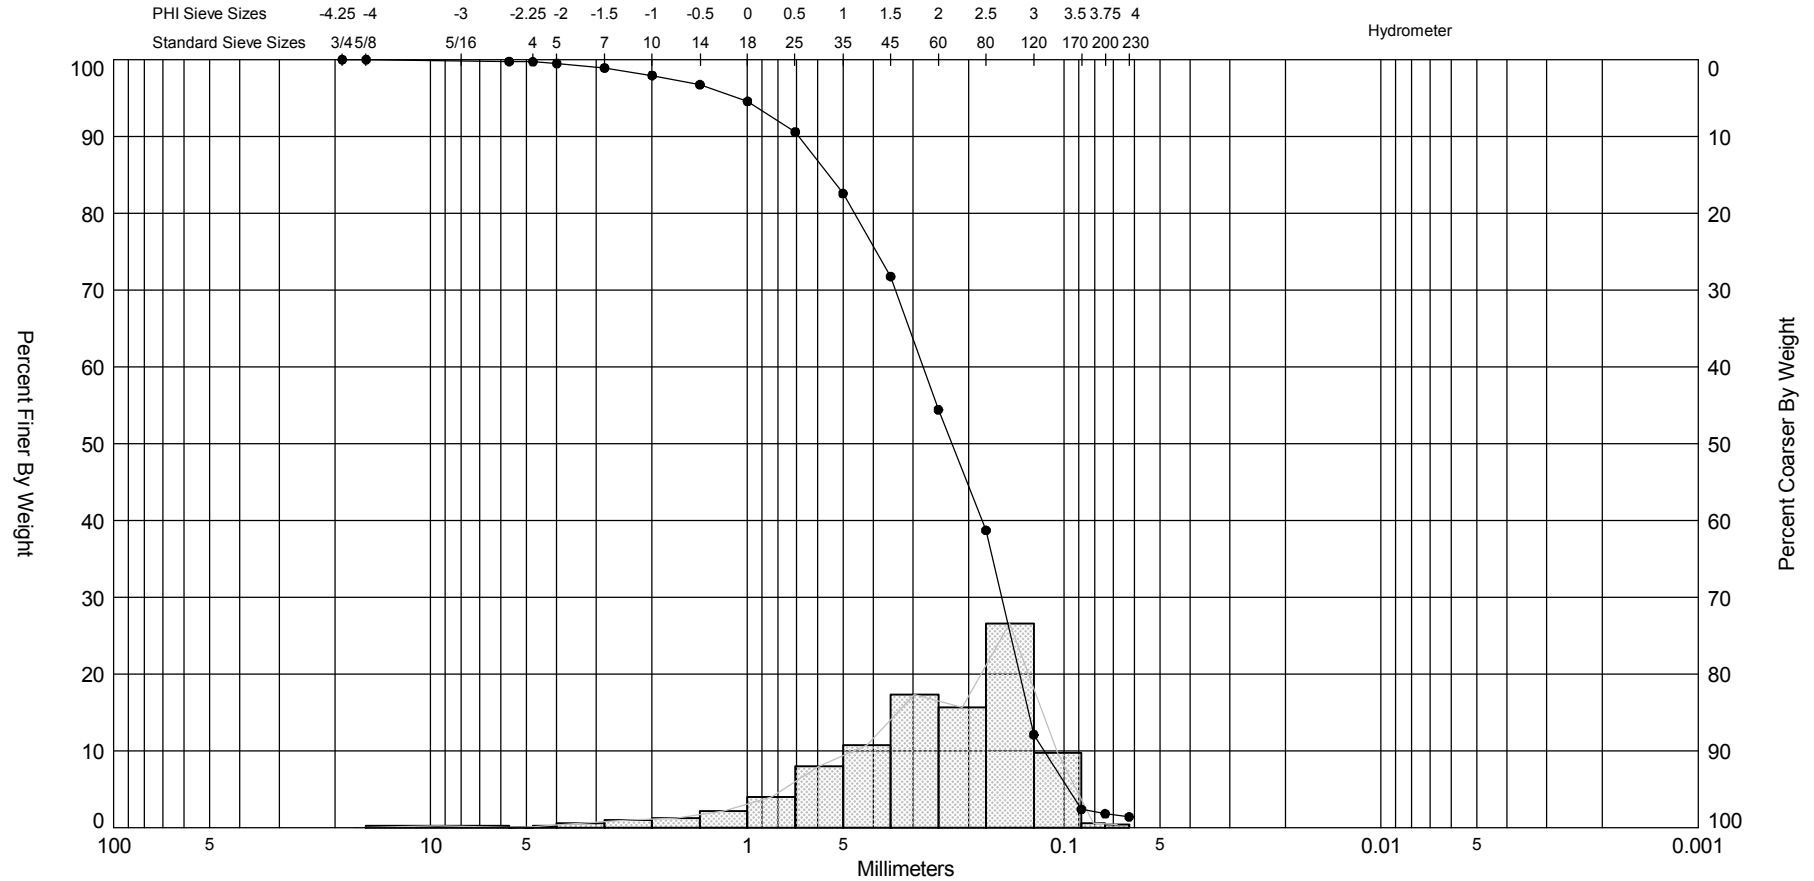
Gravel		Sand			Silt and Clay
Coarse	Fine	Coarse	Medium	Fine

Sample	Symbol	Elev. (ft)	USCS	% Fines	% Organics	% Carbonates	Median	Mean	Skew	Kurt	Sort	Sample Information	
SK-Area1-V01 #A1-V1-1	—●—	-40.2	SP	#200 - 1.80 #230 - 1.40			2.14	1.92	-1.18	4.91	1.08	Project Name:	Sarasota County Public Works
Comments:												Analysis Date:	02-06-14
Depths and elevations based on measured values												Analyzed By:	CRM Sr

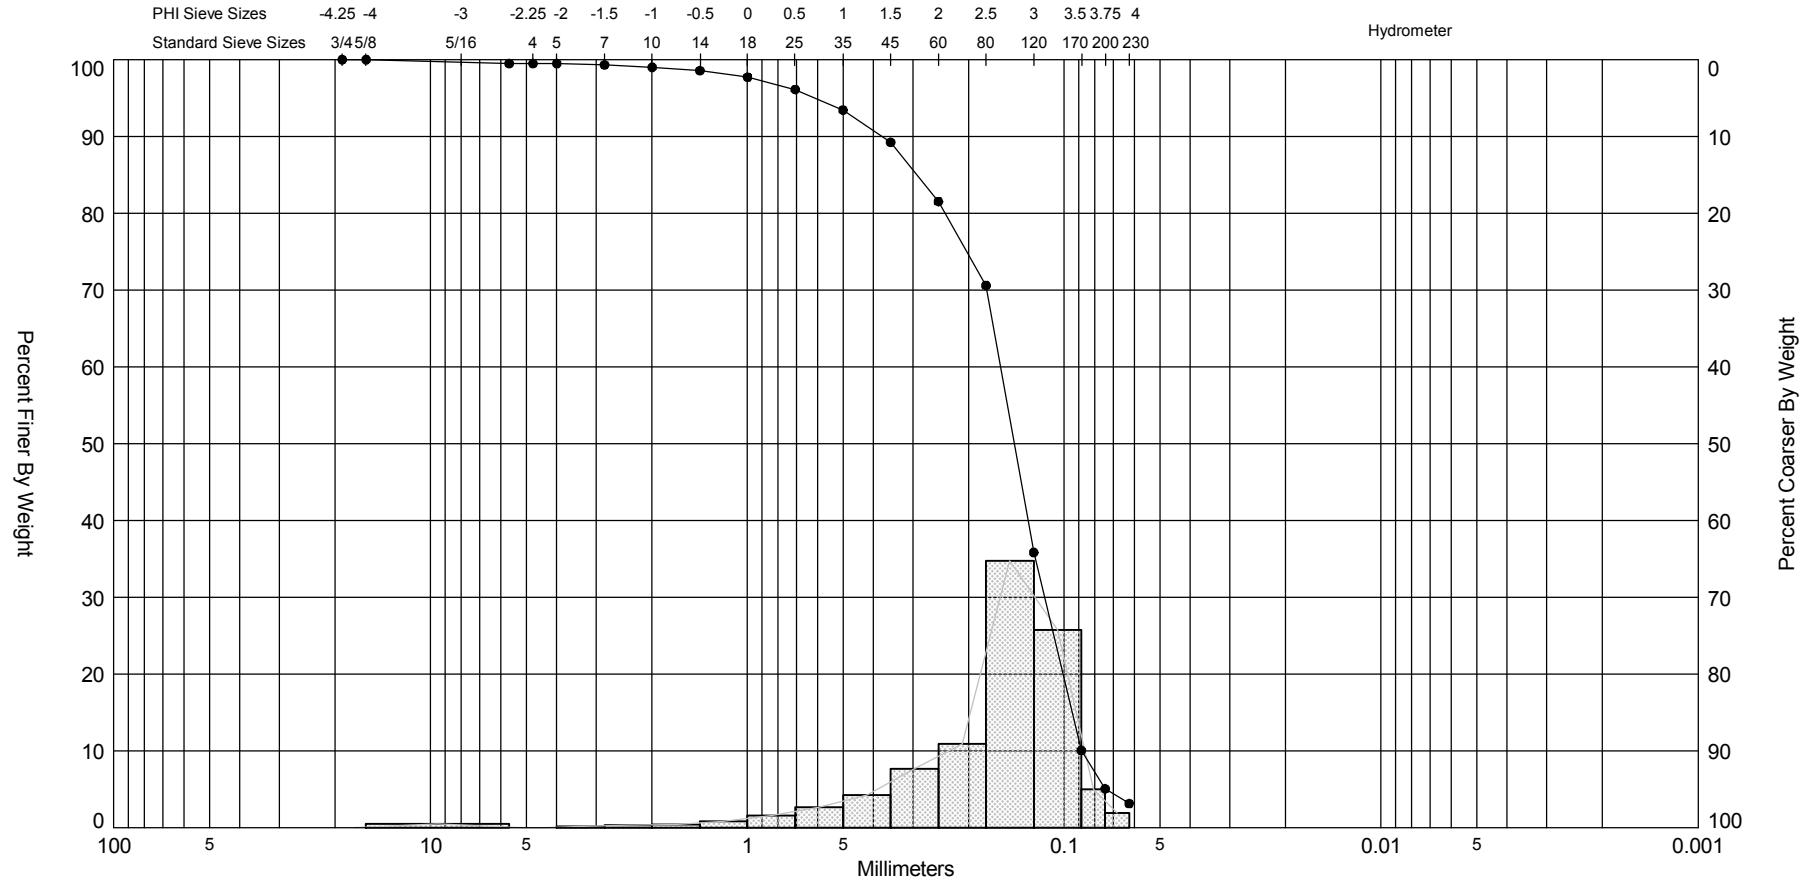
Gravel		Sand			Silt and Clay
Coarse	Fine	Coarse	Medium	Fine

Sample	Symbol	Elev. (ft)	USCS	% Fines	% Organics	% Carbonates	Median	Mean	Skew	Kurt	Sort	Sample Information	
SK-Area1-V01 #A1-V1-2	●	-41.8	SP-SM	#200 - 5.06 #230 - 3.13			2.8	2.56	-2.28	11.13	0.96	Project Name:	Sarasota County Public Works
Comments:												Analysis Date:	02-06-14
Depths and elevations based on measured values												Analyzed By:	CRM Sr
