SIEVE ANALYSIS JUNO HISTORIC_JUNE3.GPJ FL DEP ROSS.GDT 6/5/16

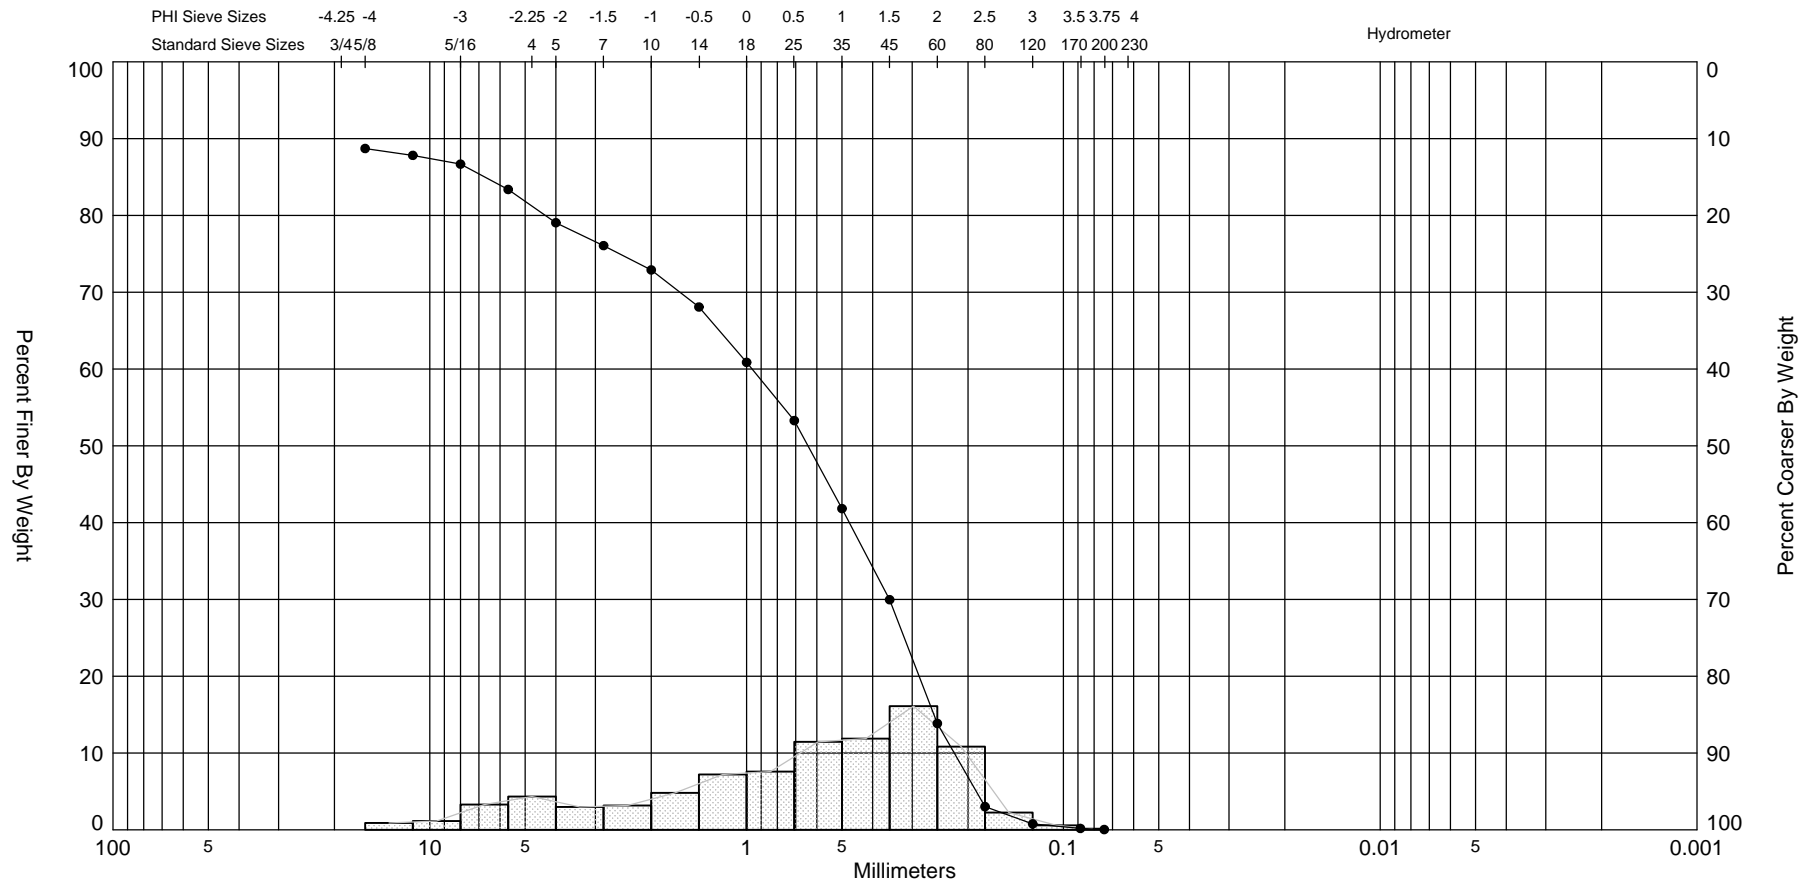
Sample	Symbol	Elev. (ft)	USCS	% Fines	% Organics	% Carbonates	Median	Mean	Skew	Kurt	Sort	Sample Information	
PB-95-C08 #0.5	—●—	-68.3		#200 - 0.04		68.57	0.64	-0.02	0.25	2.21	1.57	Project Name:	Juno Historic
Comments:												Analysis Date:	08-09-95
Depths and elevations based on measured values												Analyzed By:	
						Scientific Environmental Applications 5575 Willoughby Drive Melbourne, FL 32934 seappinc.com seapp1@aol.com (321) 254-2708						Easting (X, ft):	967,099
												Northing (Y, ft):	956,108
												Horizontal System:	NAD 1983
												Vertical System:	NAVD 88

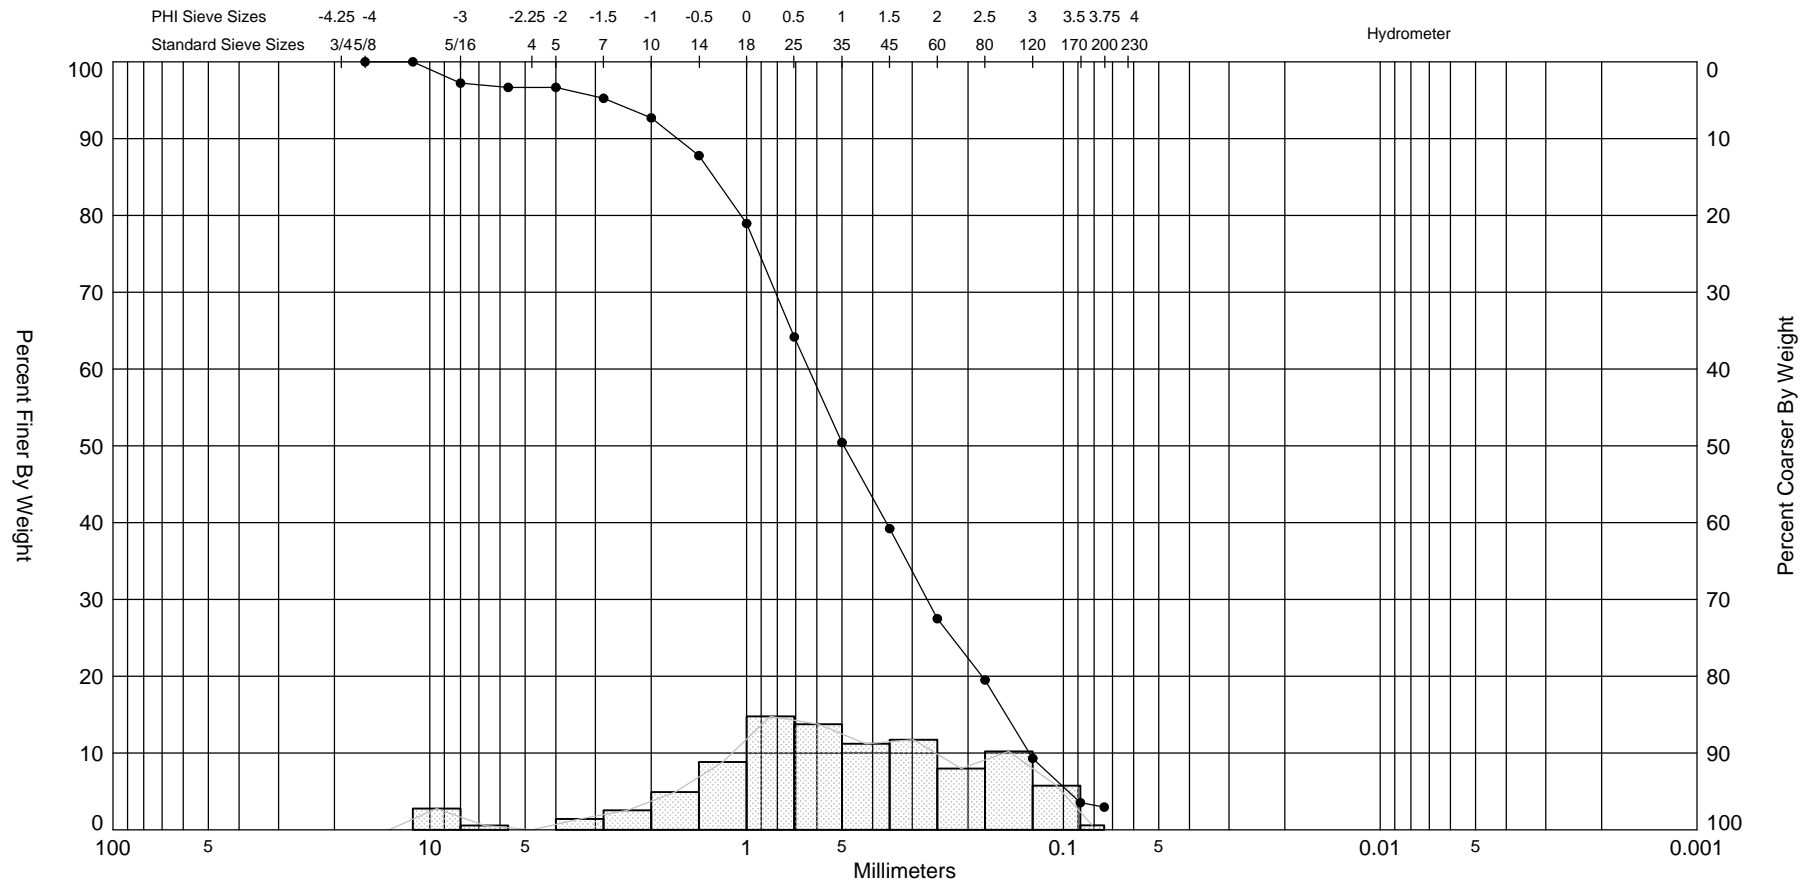
Sample	Symbol	Elev. (ft)	USCS	% Fines	% Organics	% Carbonates	Median	Mean	Skew	Kurt	Sort	Sample Information	
PB-95-C08 #2.5	—●—	-70.3	SW	#200 - 2.96		86.34	1.02	0.96	-0.6	3.51	1.45	Project Name:	Juno Historic
Comments:												Analysis Date:	08-09-95
Depths and elevations based on measured values												Analyzed By:	
						Scientific Environmental Applications 5575 Willoughby Drive Melbourne, FL 32934 seappinc.com seapp1@aol.com (321) 254-2708						Easting (X, ft):	967,099
												Northing (Y, ft):	956,108
												Horizontal System:	NAD 1983
												Vertical System:	NAVD 88

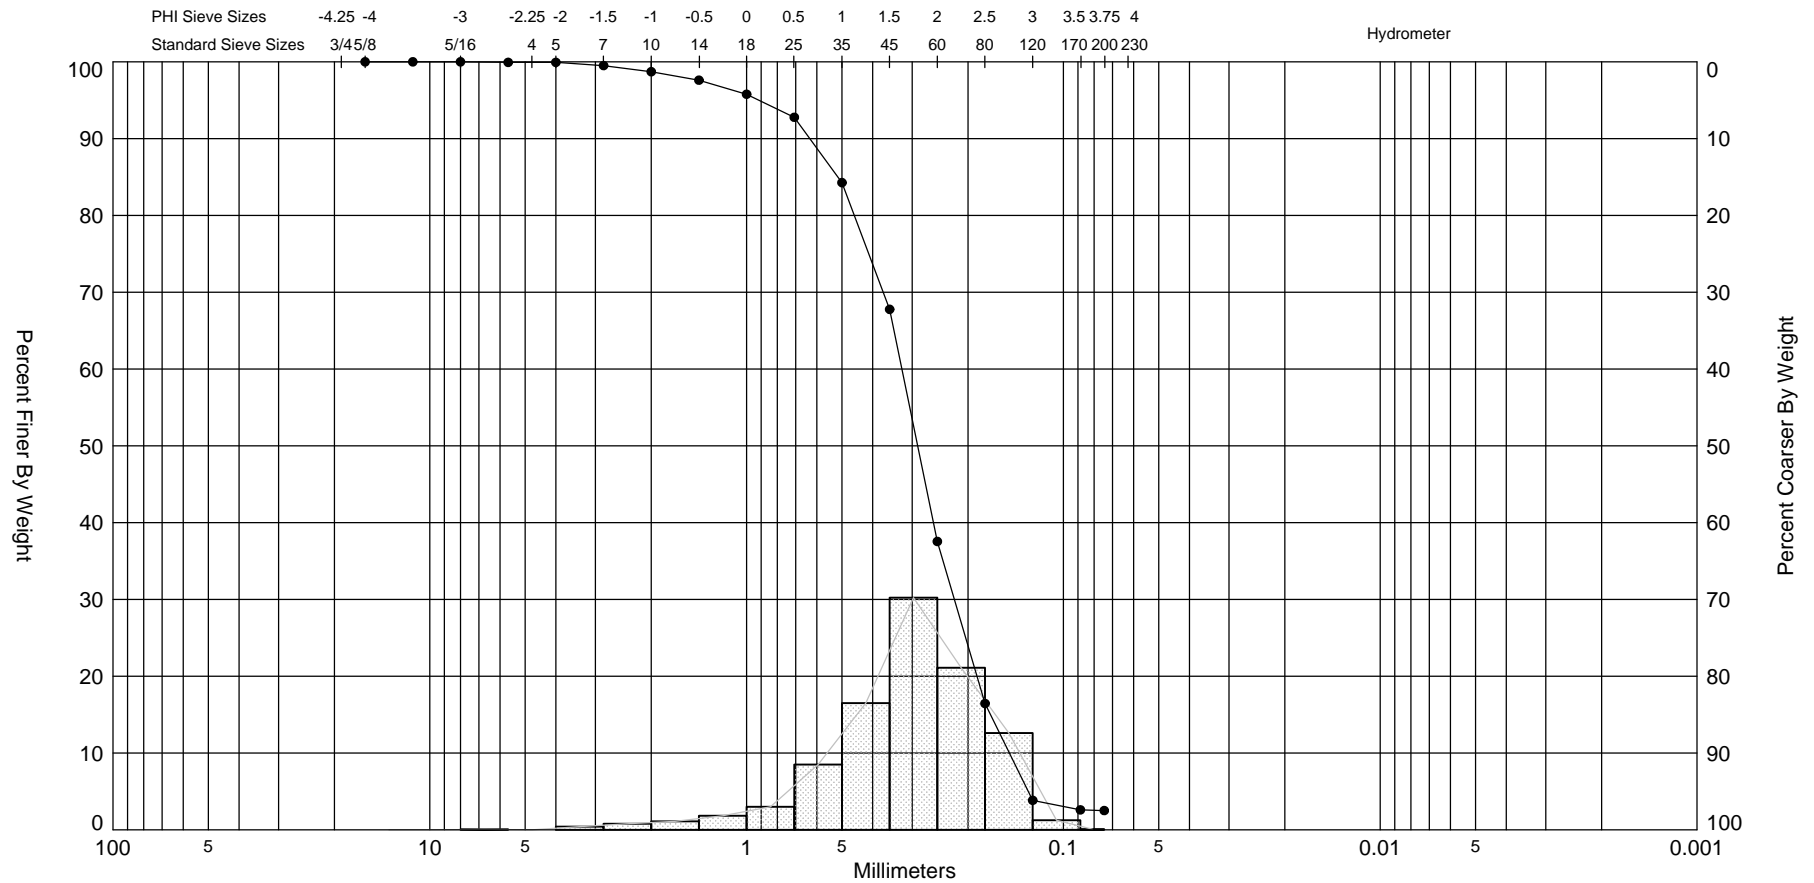
Sample	Symbol	Elev. (ft)	USCS	% Fines	% Organics	% Carbonates	Median	Mean	Skew	Kurt	Sort	Sample Information	
PB-95-C08 #4.5

-72.3	SP	#200 - 2.51		67.82	1.79	1.68	-1.14	5.4	0.83	Project Name:	Juno Historic
Comments:												Analysis Date:	08-09-95
Depths and elevations based on measured values												Analyzed By:	
						Scientific Environmental Applications 5575 Willoughby Drive Melbourne, FL 32934 seappinc.com seapp1@aol.com (321) 254-2708						Easting (X, ft):	967,099
												Northing (Y, ft):	956,108
												Horizontal System:	NAD 1983
												Vertical System:	NAVD 88

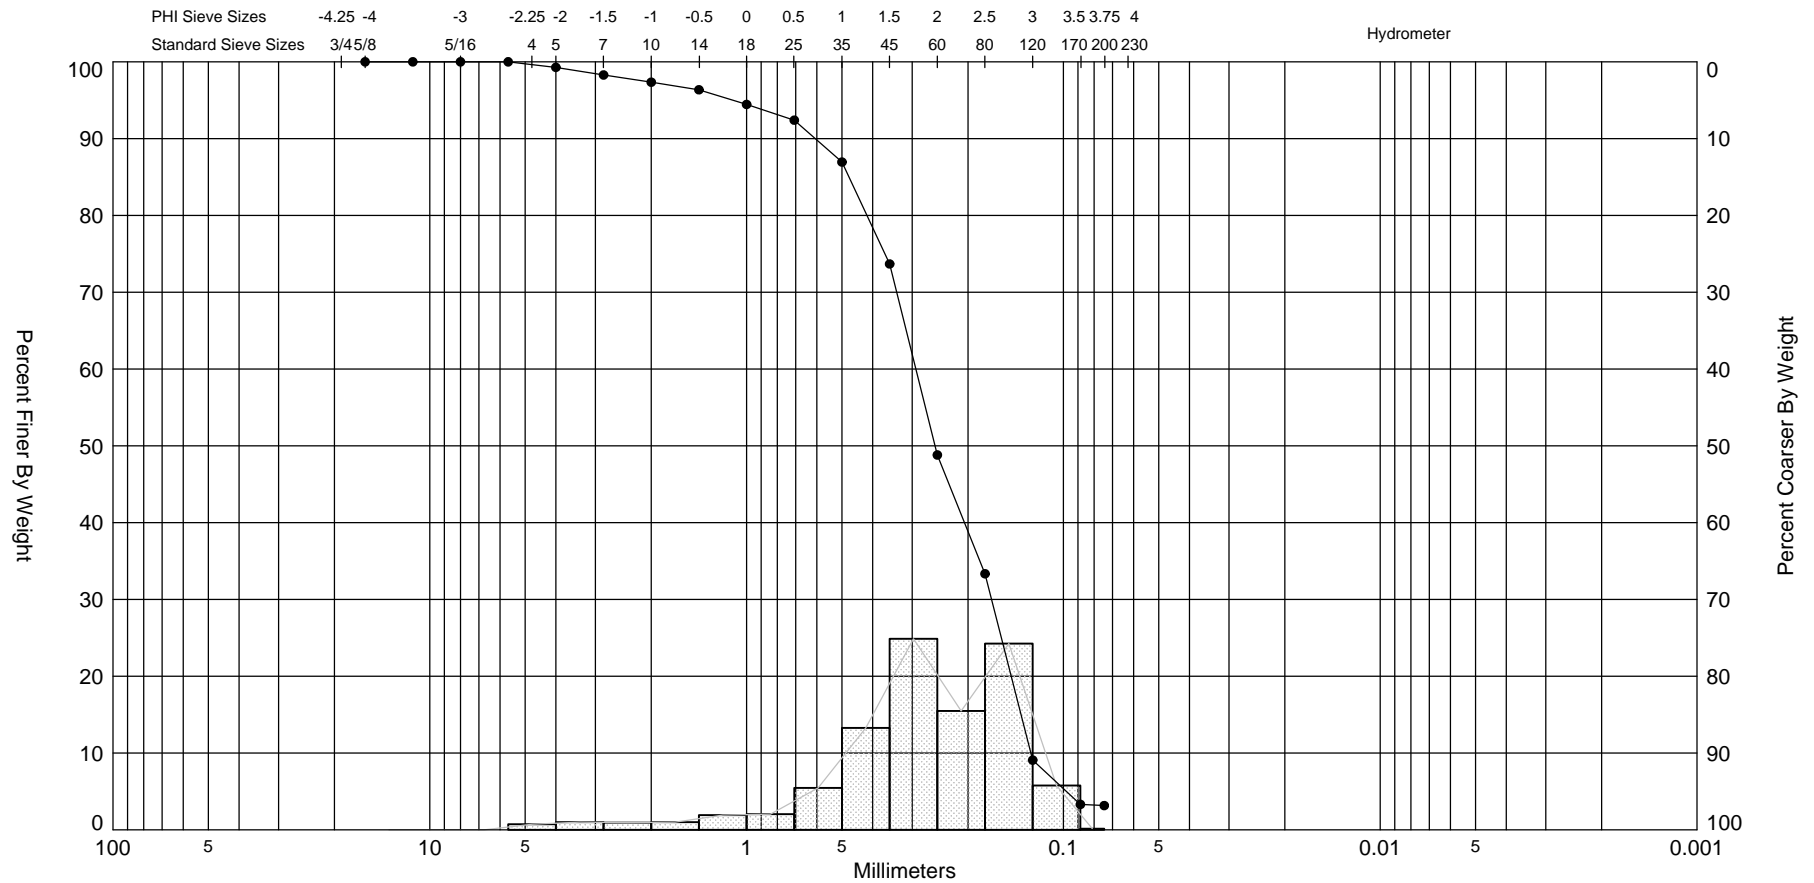
Sample	Symbol	Elev. (ft)	USCS	% Fines	% Organics	% Carbonates	Median	Mean	Skew	Kurt	Sort	Sample Information	
PB-95-C08 #6.5	—●—	-74.3	SW	#200 - 3.16		70.17	1.98	1.86	-1.42	5.88	1.02	Project Name:	Juno Historic
Comments:												Analysis Date:	08-09-95
Depths and elevations based on measured values												Analyzed By:	
						Scientific Environmental Applications 5575 Willoughby Drive Melbourne, FL 32934 seappinc.com seapp1@aol.com (321) 254-2708						Easting (X, ft):	967,099
												Northing (Y, ft):	956,108
												Horizontal System:	NAD 1983
												Vertical System:	NAVD 88

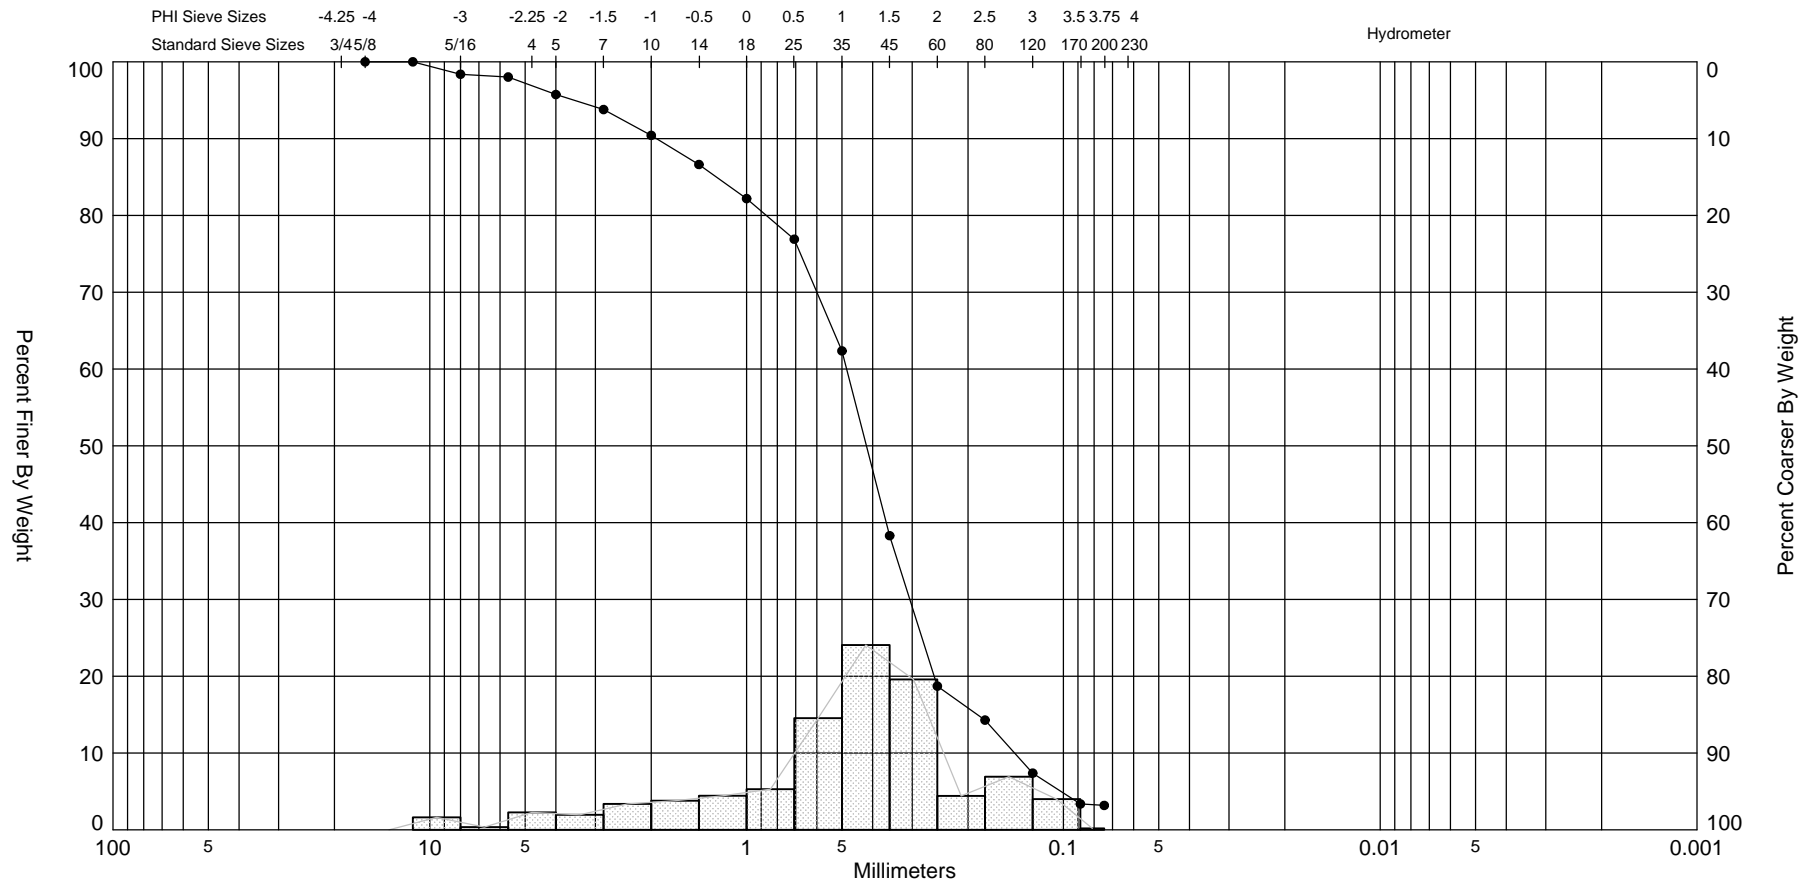
Sample	Symbol	Elev. (ft)	USCS	% Fines	% Organics	% Carbonates	Median	Mean	Skew	Kurt	Sort	Sample Information	
PB-95-C08 #8.5	—●—	-76.3	SW	#200 - 3.18		71.86	1.26	0.99	-0.96	4.08	1.34	Project Name:	Juno Historic
Comments:												Analysis Date:	08-09-95
Depths and elevations based on measured values												Analyzed By:	
						Scientific Environmental Applications 5575 Willoughby Drive Melbourne, FL 32934 seappinc.com seapp1@aol.com (321) 254-2708						Easting (X, ft):	967,099
												Northing (Y, ft):	956,108
												Horizontal System:	NAD 1983
												Vertical System:	NAVD 88

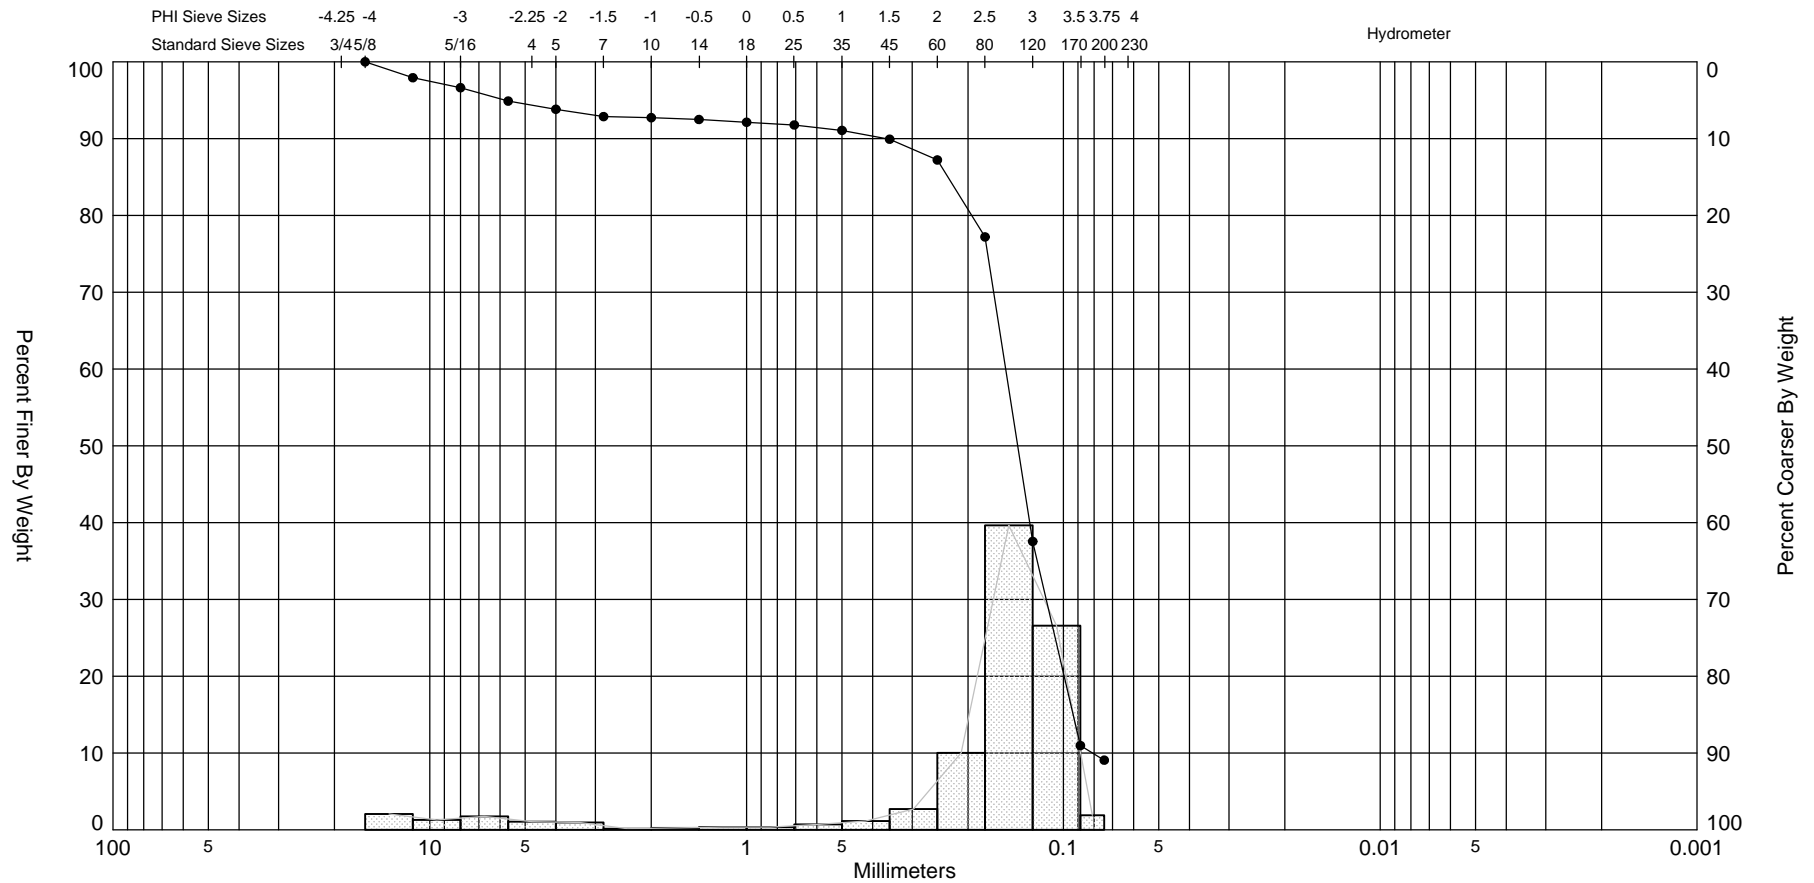
Sample	Symbol	Elev. (ft)	USCS	% Fines	% Organics	% Carbonates	Median	Mean	Skew	Kurt	Sort	Sample Information	
PB-95-C08 #10.5	—●—	-78.3		#200 - 9.07		86.45	2.84	2.31	-2.67	9.11	1.64	Project Name:	Juno Historic
Comments:												Analysis Date:	08-09-95
Depths and elevations based on measured values												Analyzed By:	
						Scientific Environmental Applications 5575 Willoughby Drive Melbourne, FL 32934 seappinc.com seapp1@aol.com (321) 254-2708						Easting (X, ft):	967,099
												Northing (Y, ft):	956,108
												Horizontal System:	NAD 1983
												Vertical System:	NAVD 88

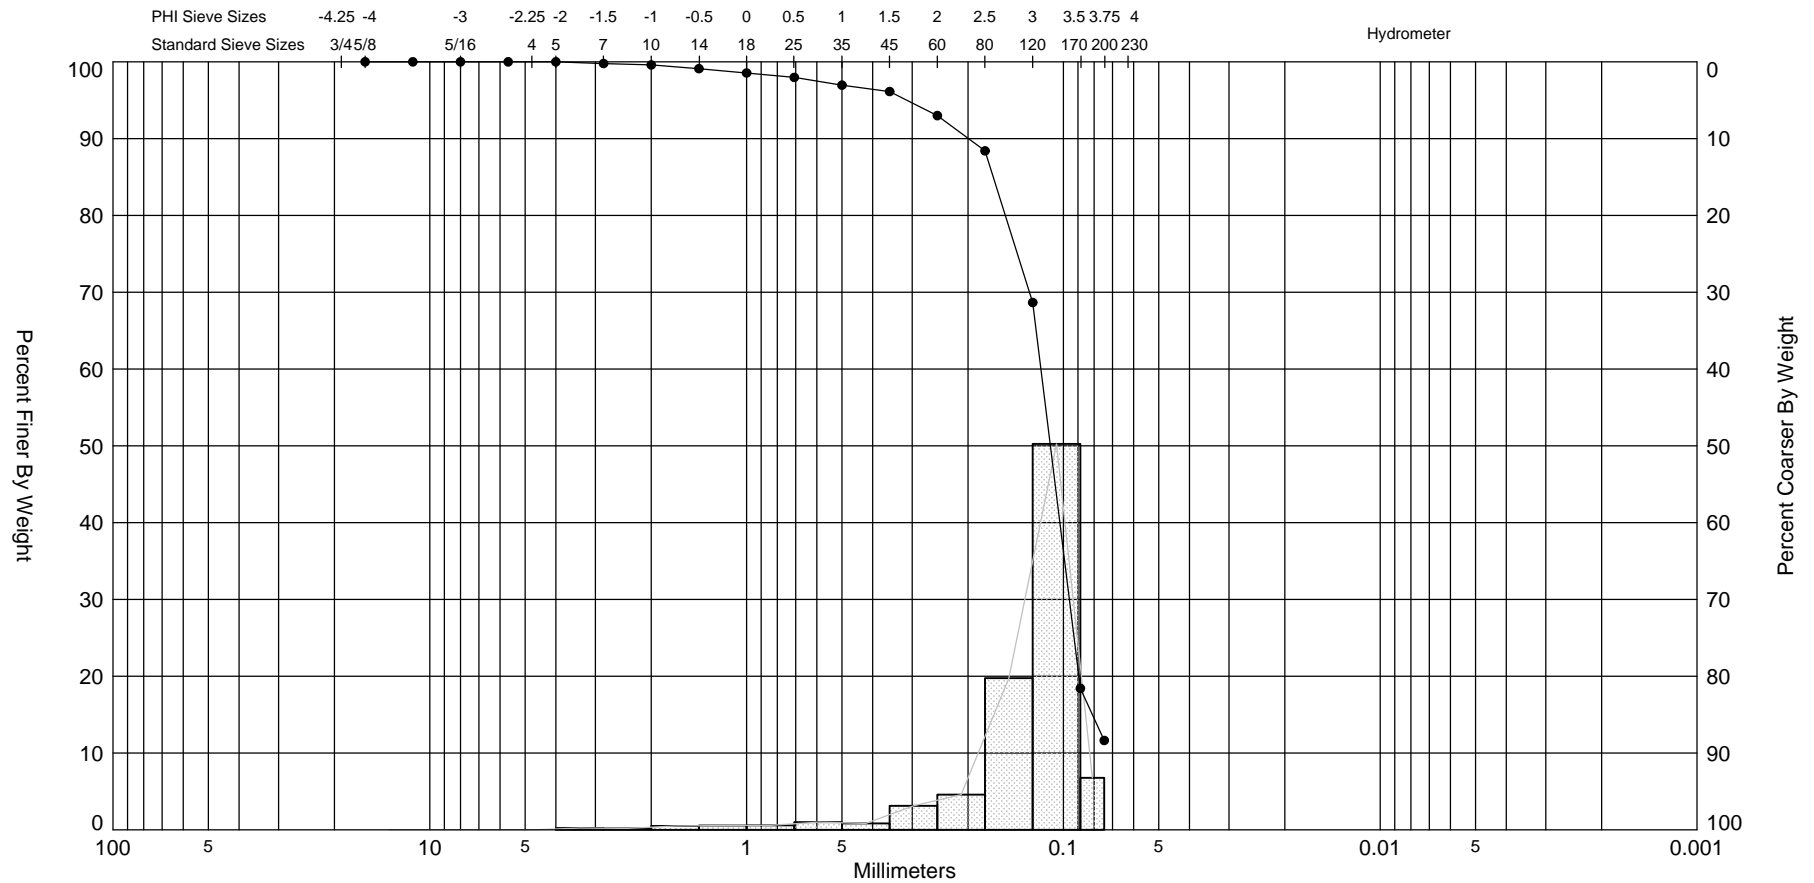
Sample	Symbol	Elev. (ft)	USCS	% Fines	% Organics	% Carbonates	Median	Mean	Skew	Kurt	Sort	Sample Information	
PB-95-C08 #12.5	—●—	-80.3		#200 - 11.64		78.06	3.19	2.93	-3.09	14.95	0.73	Project Name:	Juno Historic
Comments:												Analysis Date:	08-09-95
Depths and elevations based on measured values												Analyzed By:	
						Scientific Environmental Applications 5575 Willoughby Drive Melbourne, FL 32934 seappinc.com seapp1@aol.com (321) 254-2708						Easting (X, ft):	967,099
												Northing (Y, ft):	956,108
												Horizontal System:	NAD 1983
												Vertical System:	NAVD 88

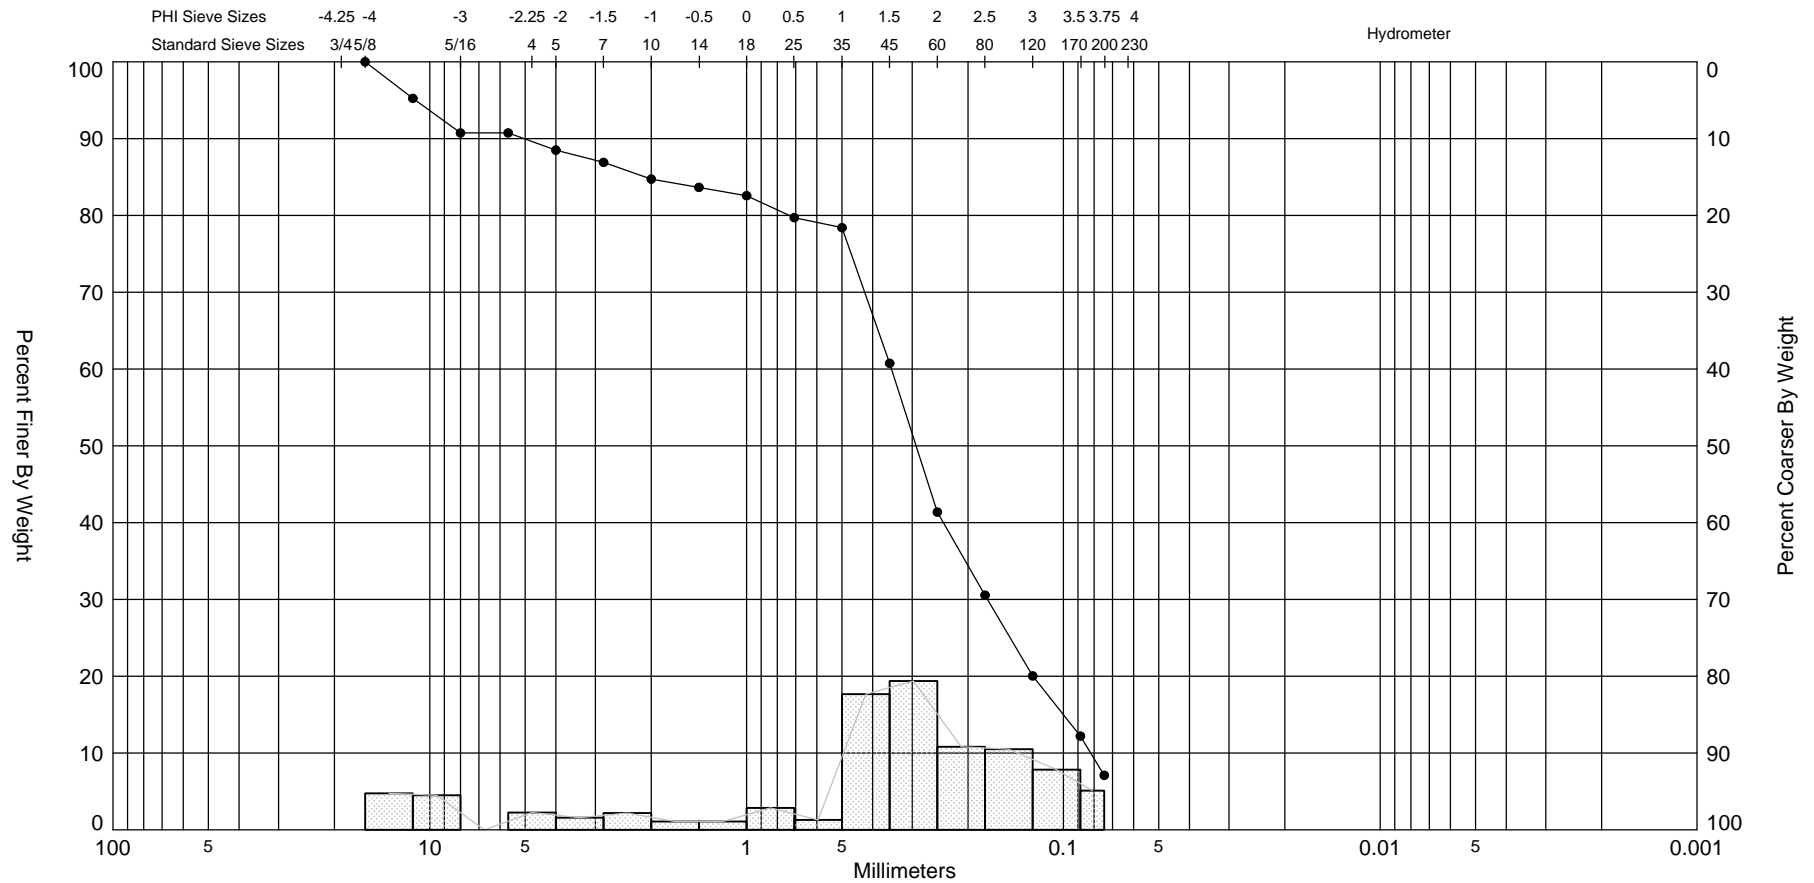
Sample	Symbol	Elev. (ft)	USCS	% Fines	% Organics	% Carbonates	Median	Mean	Skew	Kurt	Sort	Sample Information	
PB-95-C08 #15.5	—●—	-83.3		#200 - 7.10		77.02	1.78	1.19	-1.26	3.66	2.01	Project Name:	Juno Historic
Comments:												Analysis Date:	08-09-95
Depths and elevations based on measured values												Analyzed By:	
						Scientific Environmental Applications 5575 Willoughby Drive Melbourne, FL 32934 seappinc.com seapp1@aol.com (321) 254-2708						Easting (X, ft):	967,099
												Northing (Y, ft):	956,108
												Horizontal System:	NAD 1983
												Vertical System:	NAVD 88

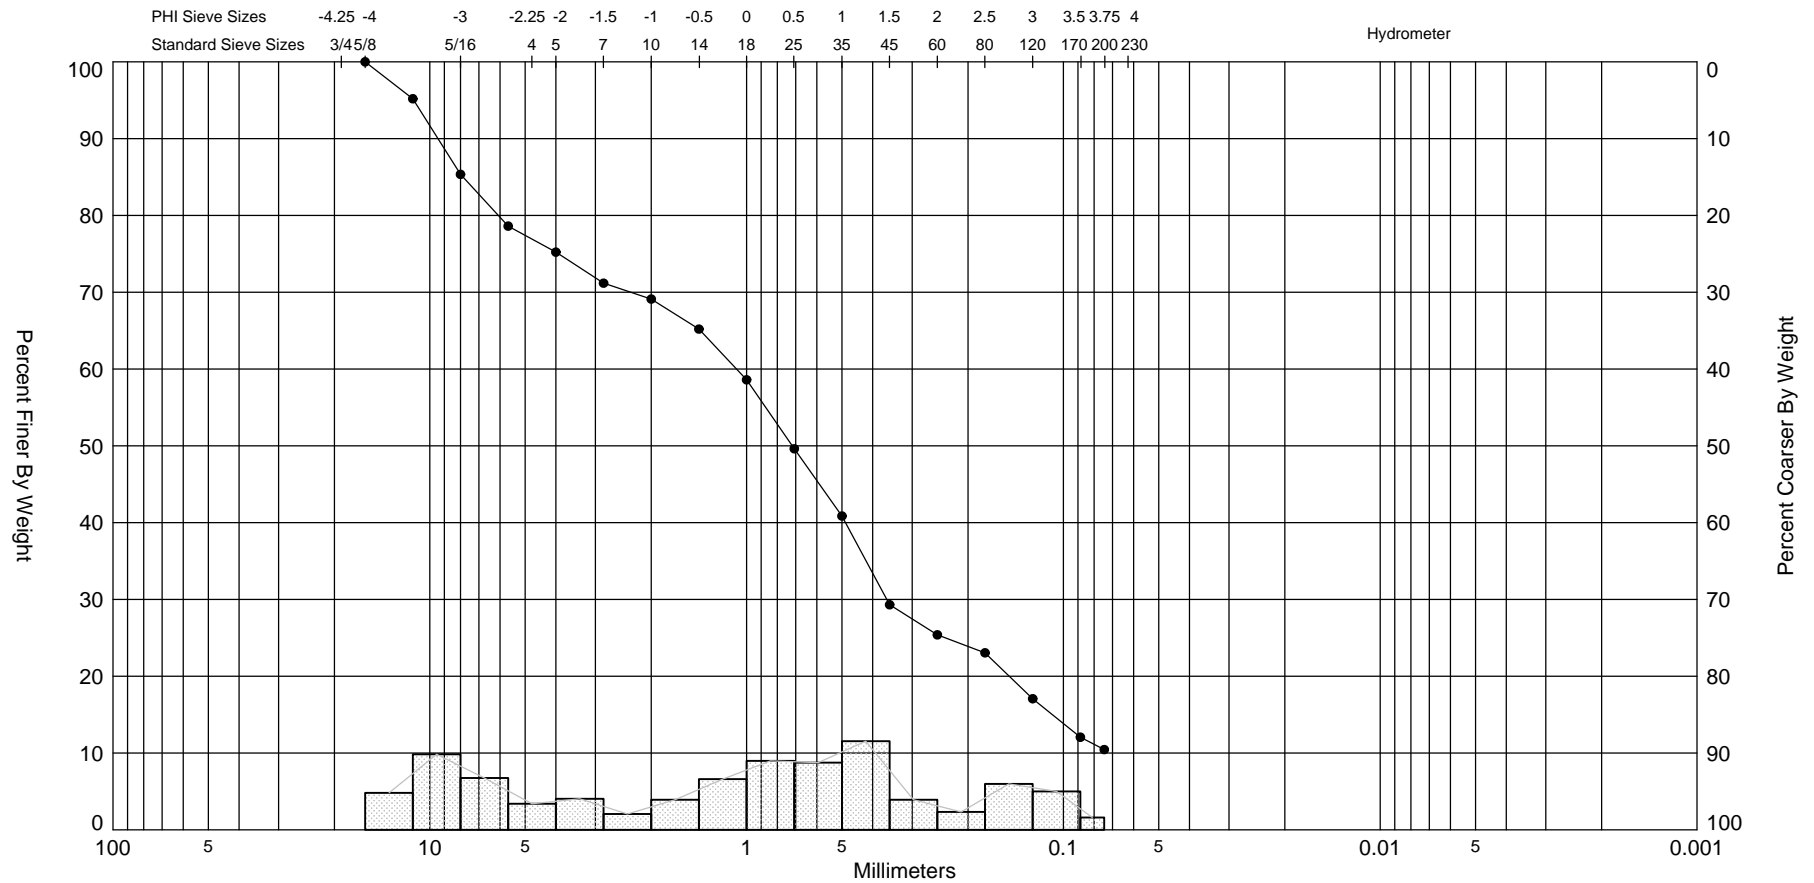
Sample	Symbol	Elev. (ft)	USCS	% Fines	% Organics	% Carbonates	Median	Mean	Skew	Kurt	Sort	Sample Information	
PB-95-C08 #17.5	—●—	-85.3		#200 - 10.45		74.71	0.48	-0.18	-0.13	1.86	2.17	Project Name:	Juno Historic
Comments:												Analysis Date:	08-09-95
Depths and elevations based on measured values												Analyzed By:	
						Scientific Environmental Applications 5575 Willoughby Drive Melbourne, FL 32934 seappinc.com seapp1@aol.com (321) 254-2708						Easting (X, ft):	967,099
												Northing (Y, ft):	956,108
												Horizontal System:	NAD 1983
												Vertical System:	NAVD 88

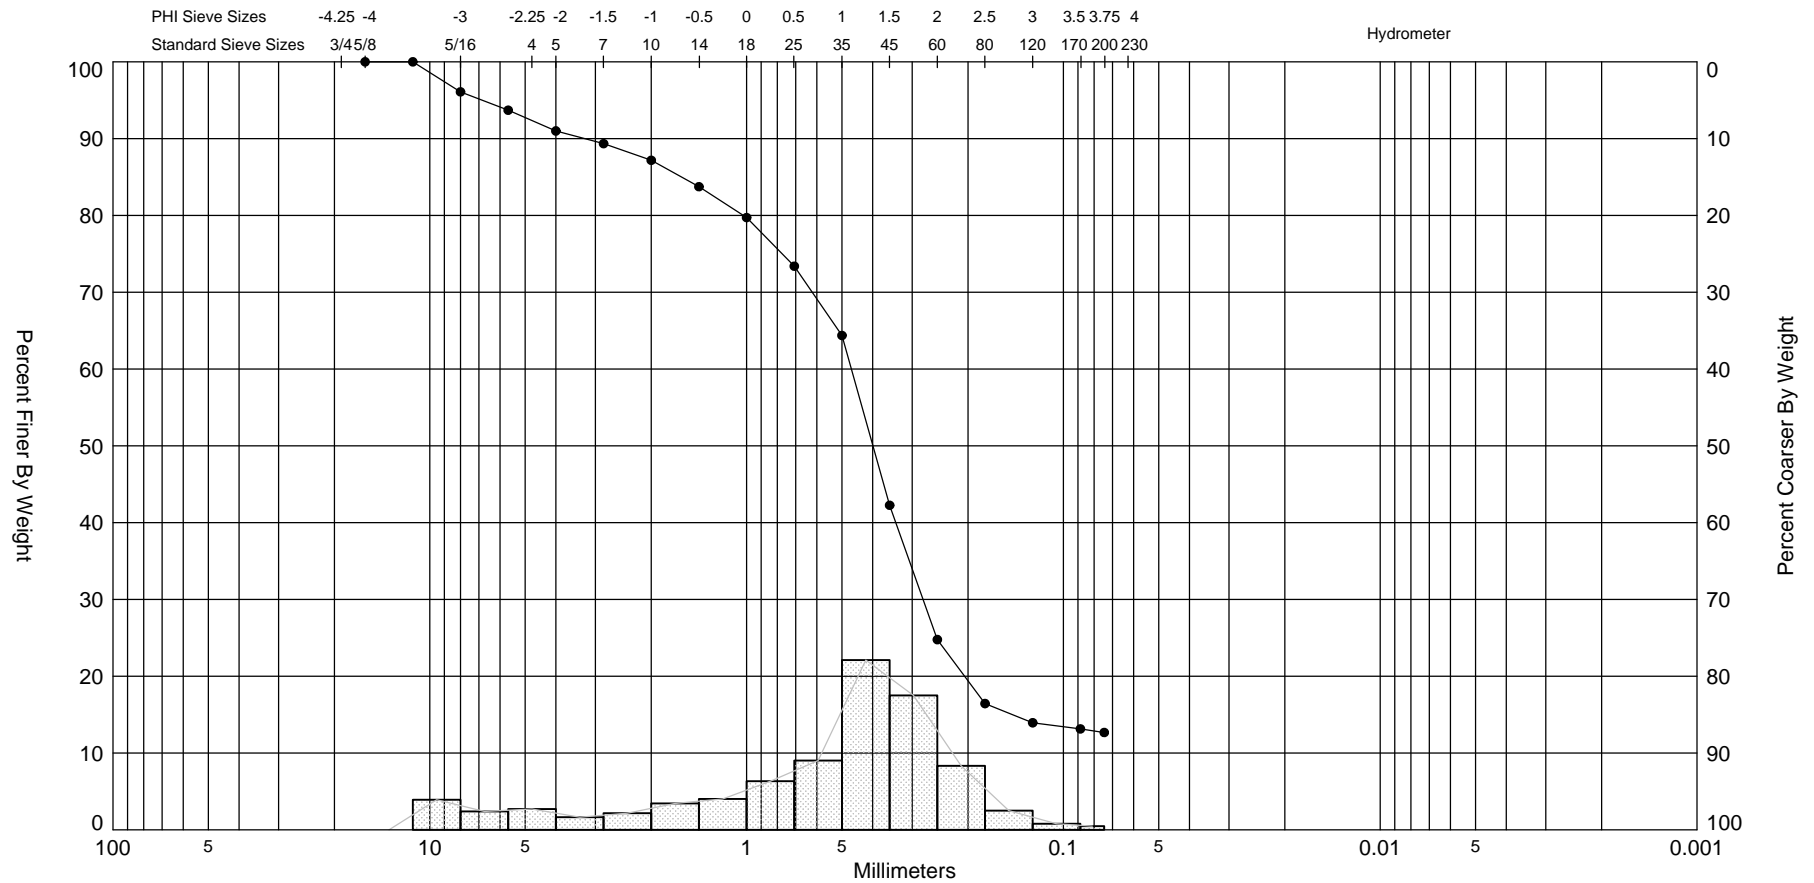
Sample	Symbol	Elev. (ft)	USCS	% Fines	% Organics	% Carbonates	Median	Mean	Skew	Kurt	Sort	Sample Information	
PB-95-C08 #Comp	—●—	-86.8		#200 - 12.67		71.71	1.32	0.71	-1.14	3.61	1.55	Project Name:	Juno Historic
Comments:												Analysis Date:	08-09-95
Depths and elevations based on measured values												Analyzed By:	
						Scientific Environmental Applications 5575 Willoughby Drive Melbourne, FL 32934 seappinc.com seapp1@aol.com (321) 254-2708						Easting (X, ft):	967,099
												Northing (Y, ft):	956,108
												Horizontal System:	NAD 1983
												Vertical System:	NAVD 88
