American Vibracore Services, Inc. 1215 Wallace Drive Delray Beach, FL 33444						Easting (X, ft):	967398.
												Northing (Y, ft):	973737.
												Horizontal System:	NAD 1983
												Vertical System:	NAVD 88

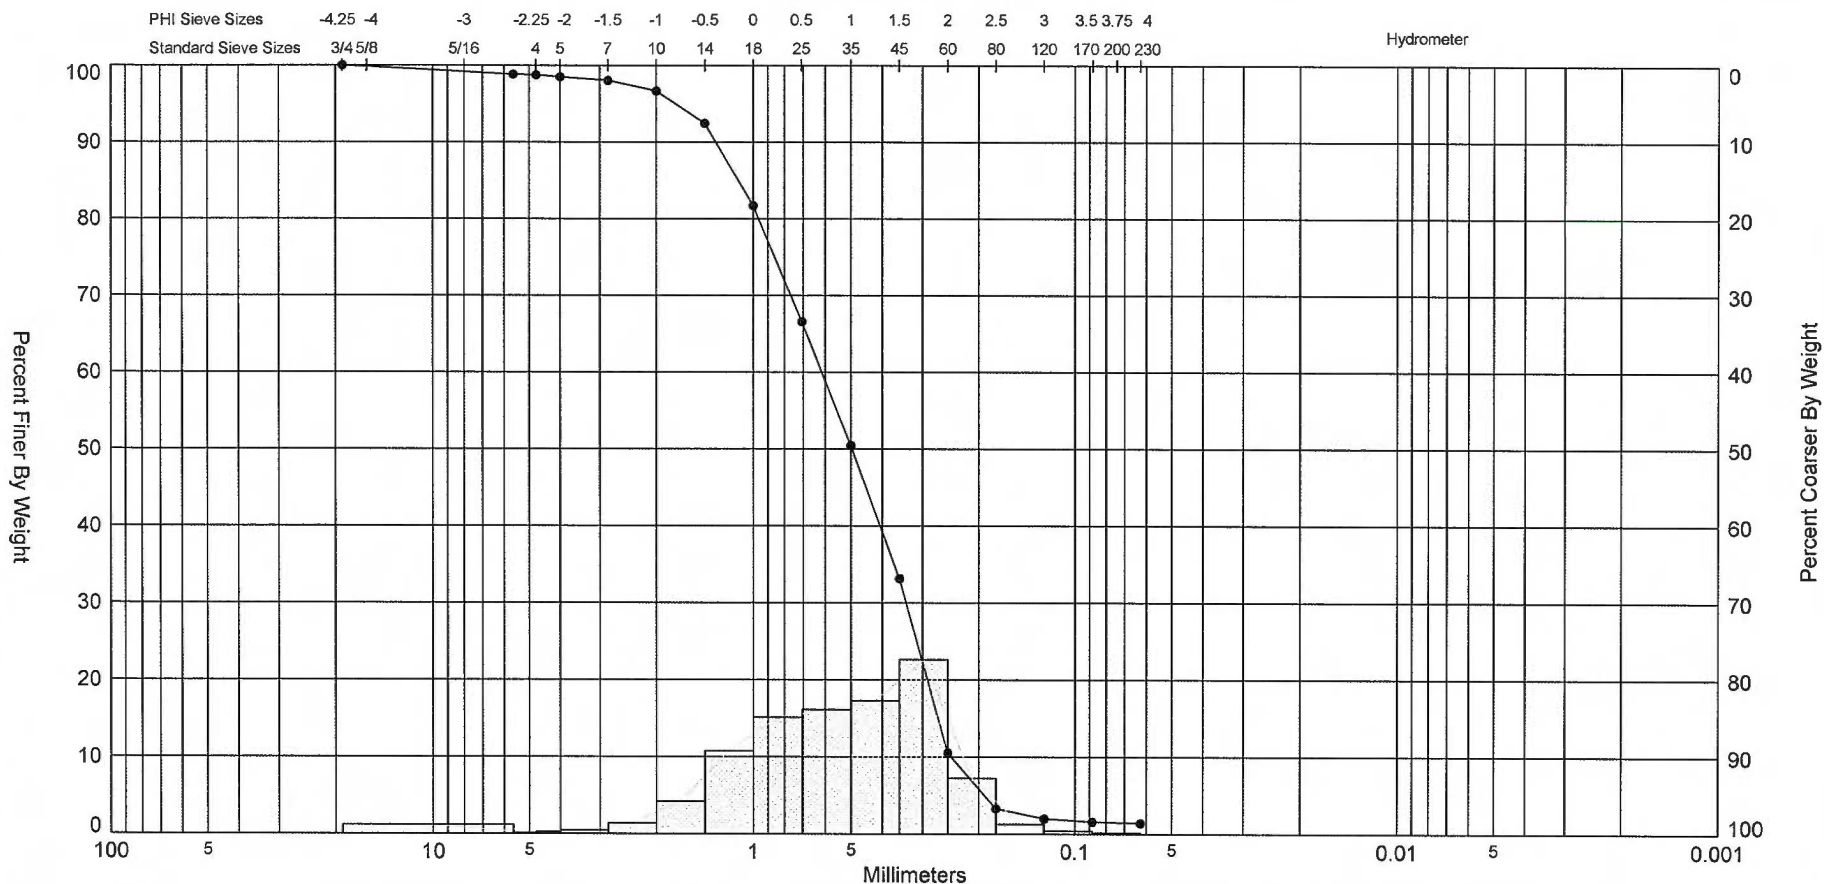
Sample	Symbol	Elev. (ft)	USCS	% Fines	% Organics	% Carbonates	Median	Mean	Skew	Kurt	Sort	Sample Information	
JL-19 #S-1 (1')

-50.0	SW	#230 - 1.40		77.00	1.01	0.87	-0.94	5.13	1.04	Project Name:	Jupiter Island 10
Comments: 10 YR 5/1 Munsell @ 10% Moisture												Analysis Date:	04-21-10
Depths and elevations based on measured values												Analyzed By:	ML

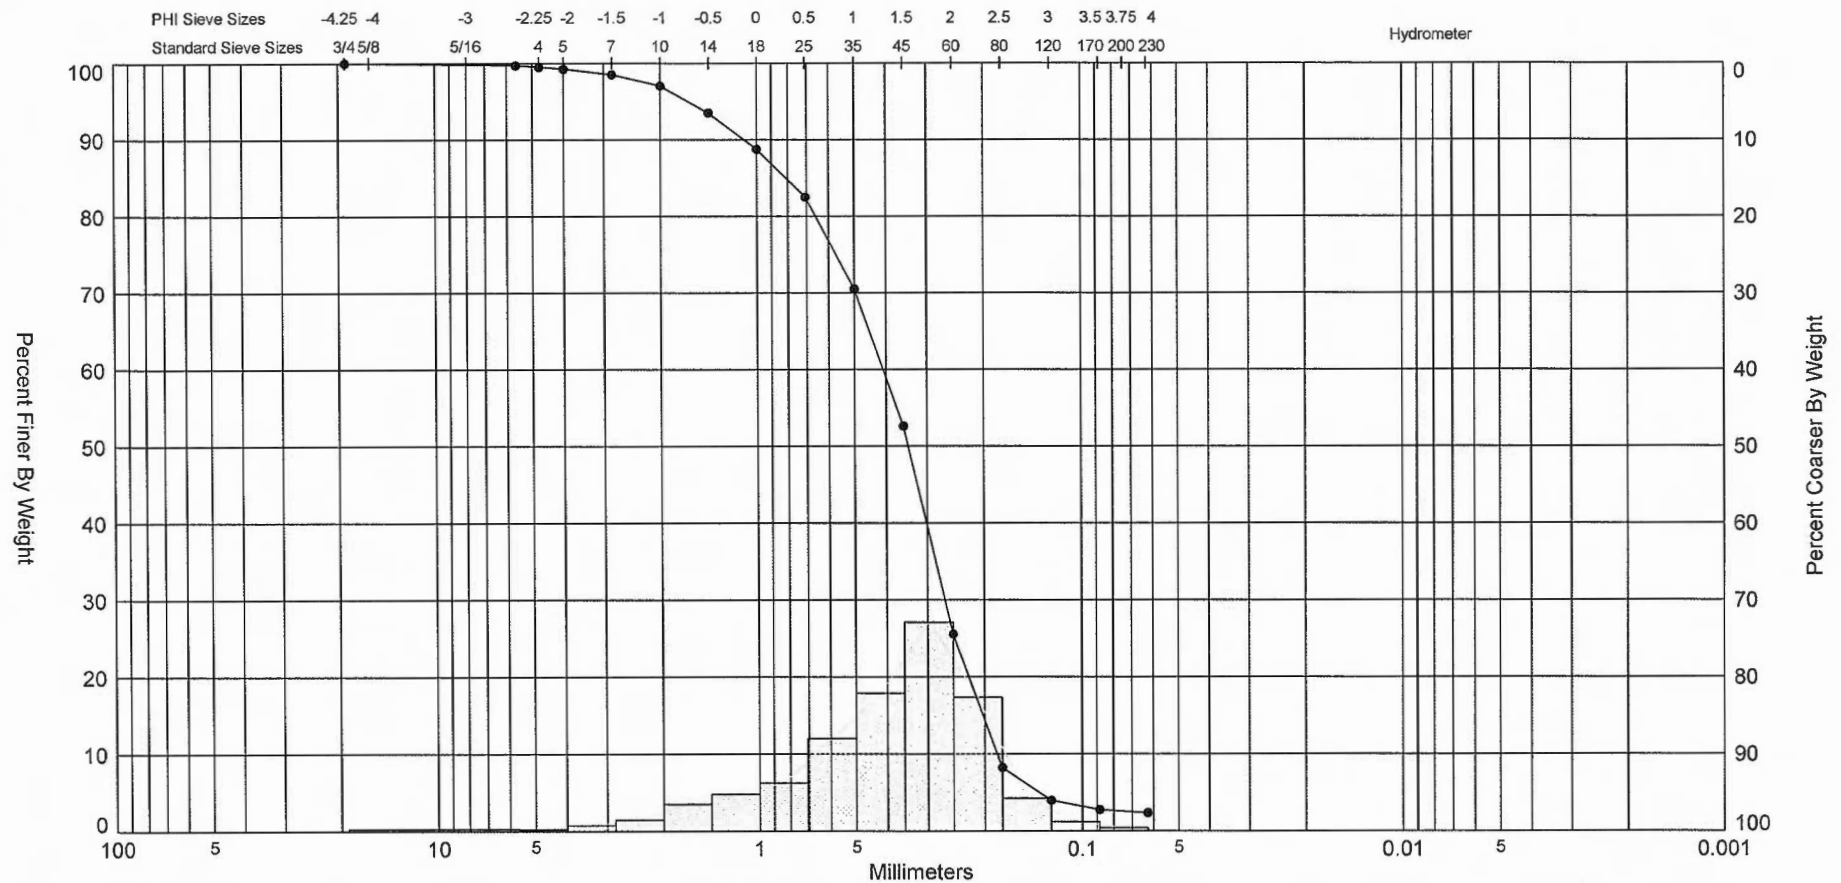
Sample	Symbol	Elev. (ft)	USCS	% Fines	% Organics	% Carbonates	Median	Mean	Skew	Kurt	Sort	Sample Information	
Jl-19 #S-2 (7")	—●—	-56.0	SW	#230 - 2.35			1.55	1.3	-1.05	4.73	1.03	Project Name:	Jupiter Island 10
Comments: 10 YR 5/1 Munsell @ 10% Moisture												Analysis Date:	04-21-10
Depths and elevations based on measured values												Analyzed By:	JR

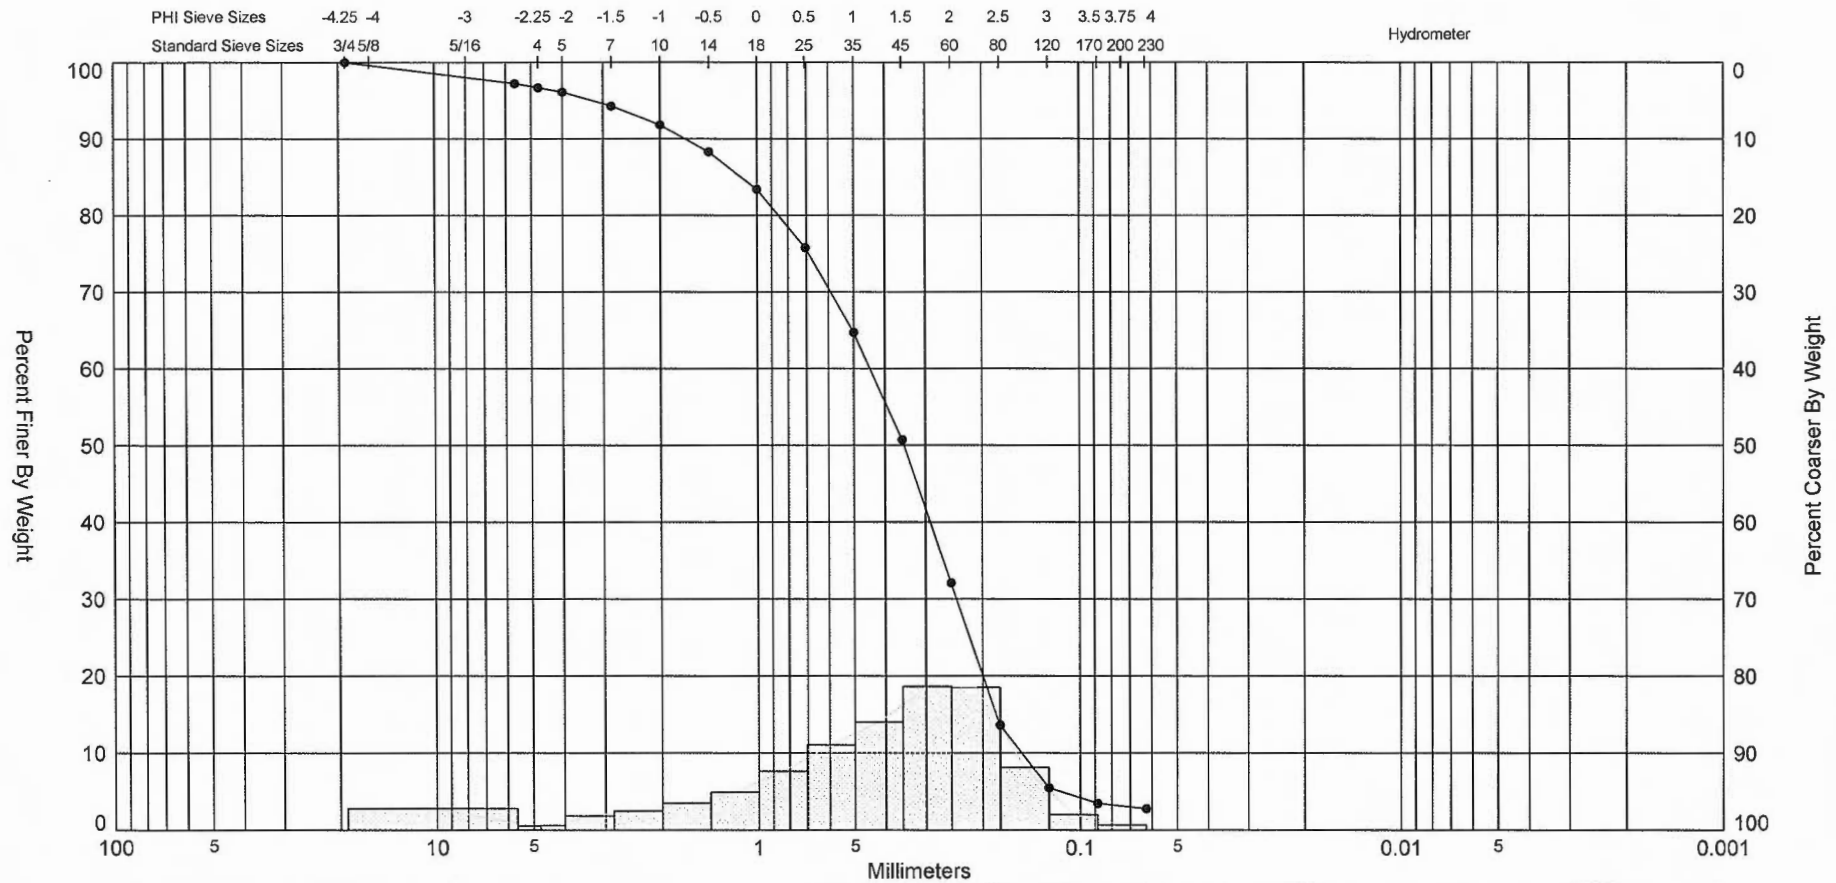
Sample	Symbol	Elev. (ft)	USCS	% Fines	% Organics	% Carbonates	Median	Mean	Skew	Kurt	Sort	Sample Information	
Jl-19 #S-3 (10.1')	—●—	-59.1	SW	#230 - 2.77		67.60	1.52	1.14	-1.21	4.54	1.41	Project Name:	Jupiter Island 10
Comments: 10 YR 4/1 Munsell @ 10% Moisture												Analysis Date:	04-23-10
Depths and elevations based on measured values												Analyzed By:	ML

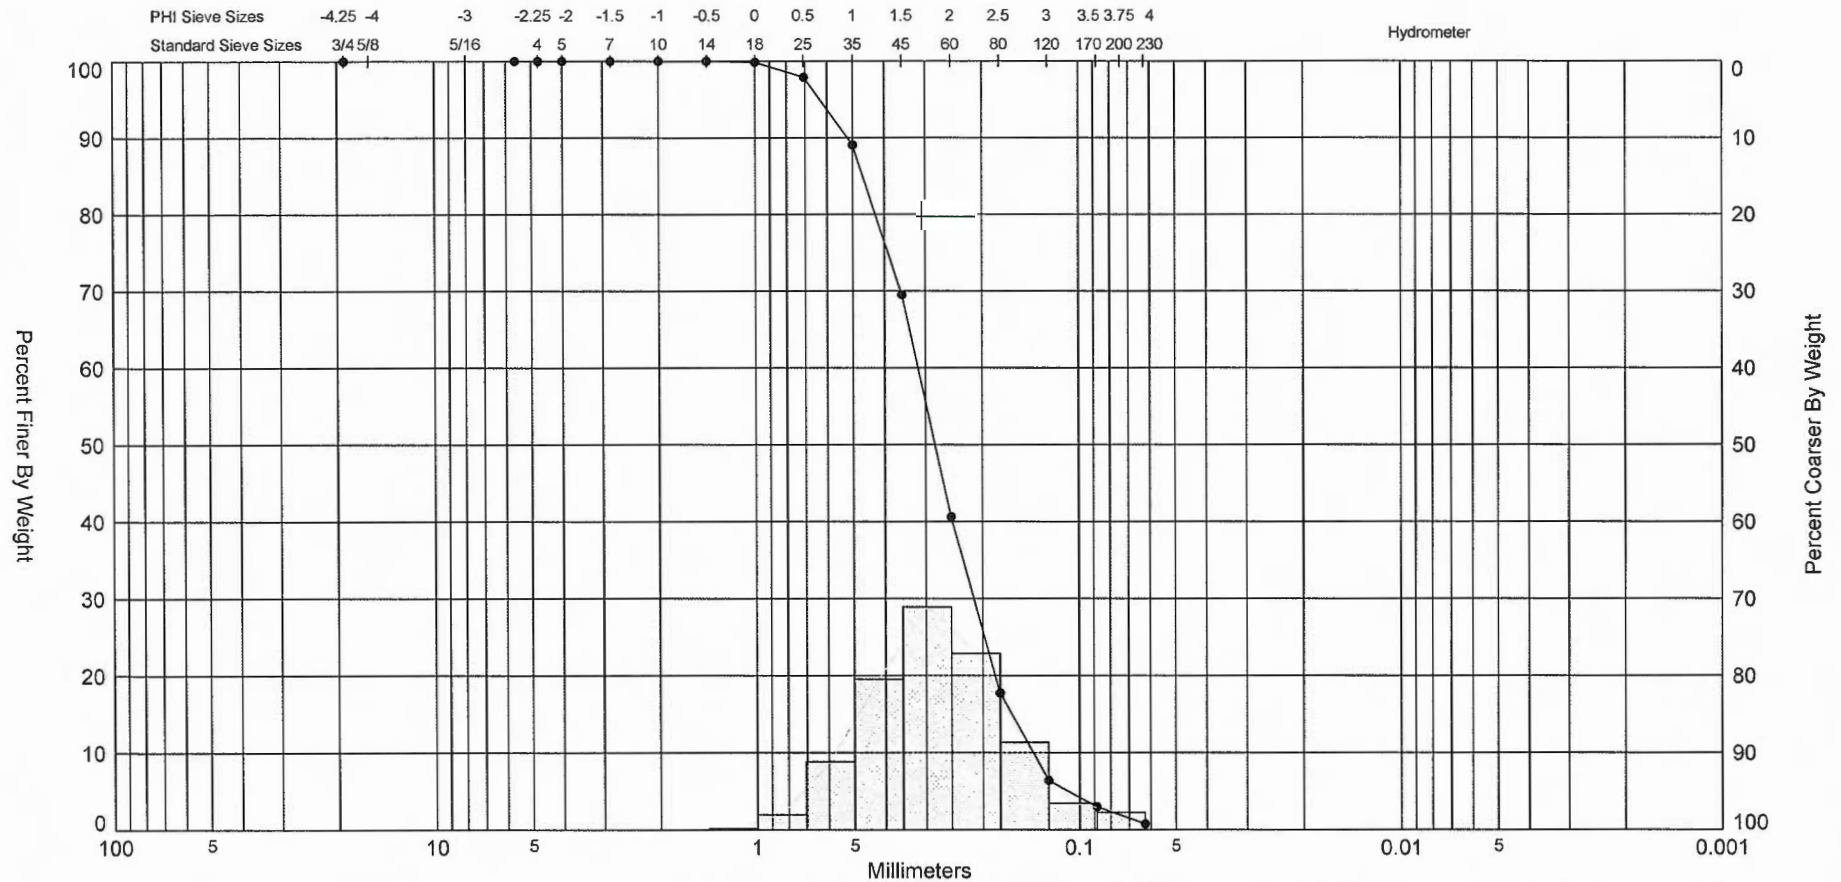
Sample	Symbol	Elev. (ft)	USCS	% Fines	% Organics	% Carbonates	Median	Mean	Skew	Kurt	Sort	Sample Information	
JL-19 PCC #S-1 (10.1')	—●—	-59.1	SP	#230 - 0.74			1.84	1.86	0.22	3.07	0.72	Project Name:	Jupiter Island 10
Comments: 10 YR 4/1 Munsell @ 10% moisture. Sample after calcium carbonate.												Analysis Date:	02-23-10
Depths and elevations based on measured values												Analyzed By:	ML
