Sample	Symbol	Elev. (ft)	USCS	% Fines	% Organics	% Carbonates	Median	Mean	Skew	Kurt	Sort	Sample Information	
JIVC-10-50 #S-1 (1')		-47.4	SP	#230 - 1.05		59.10	1.84	1.78	-1.16	6.31	0.58	Project Name:	Jupiter Island 10 Detail Phase
Comments: Visual Shell Content = 0%												Analysis Date:	11-30-10
Depths and elevations based on measured values												Analyzed By:	ML

AMERICAN VIBRACORE SERVICES						American Vibracore Services, Inc. 1215 Wallace Drive Delray Beach, FL 33444						Easting (X, ft):	968726.
												Northing (Y, ft):	978358.
												Horizontal System:	NAD 1983
												Vertical System:	NAVD 88

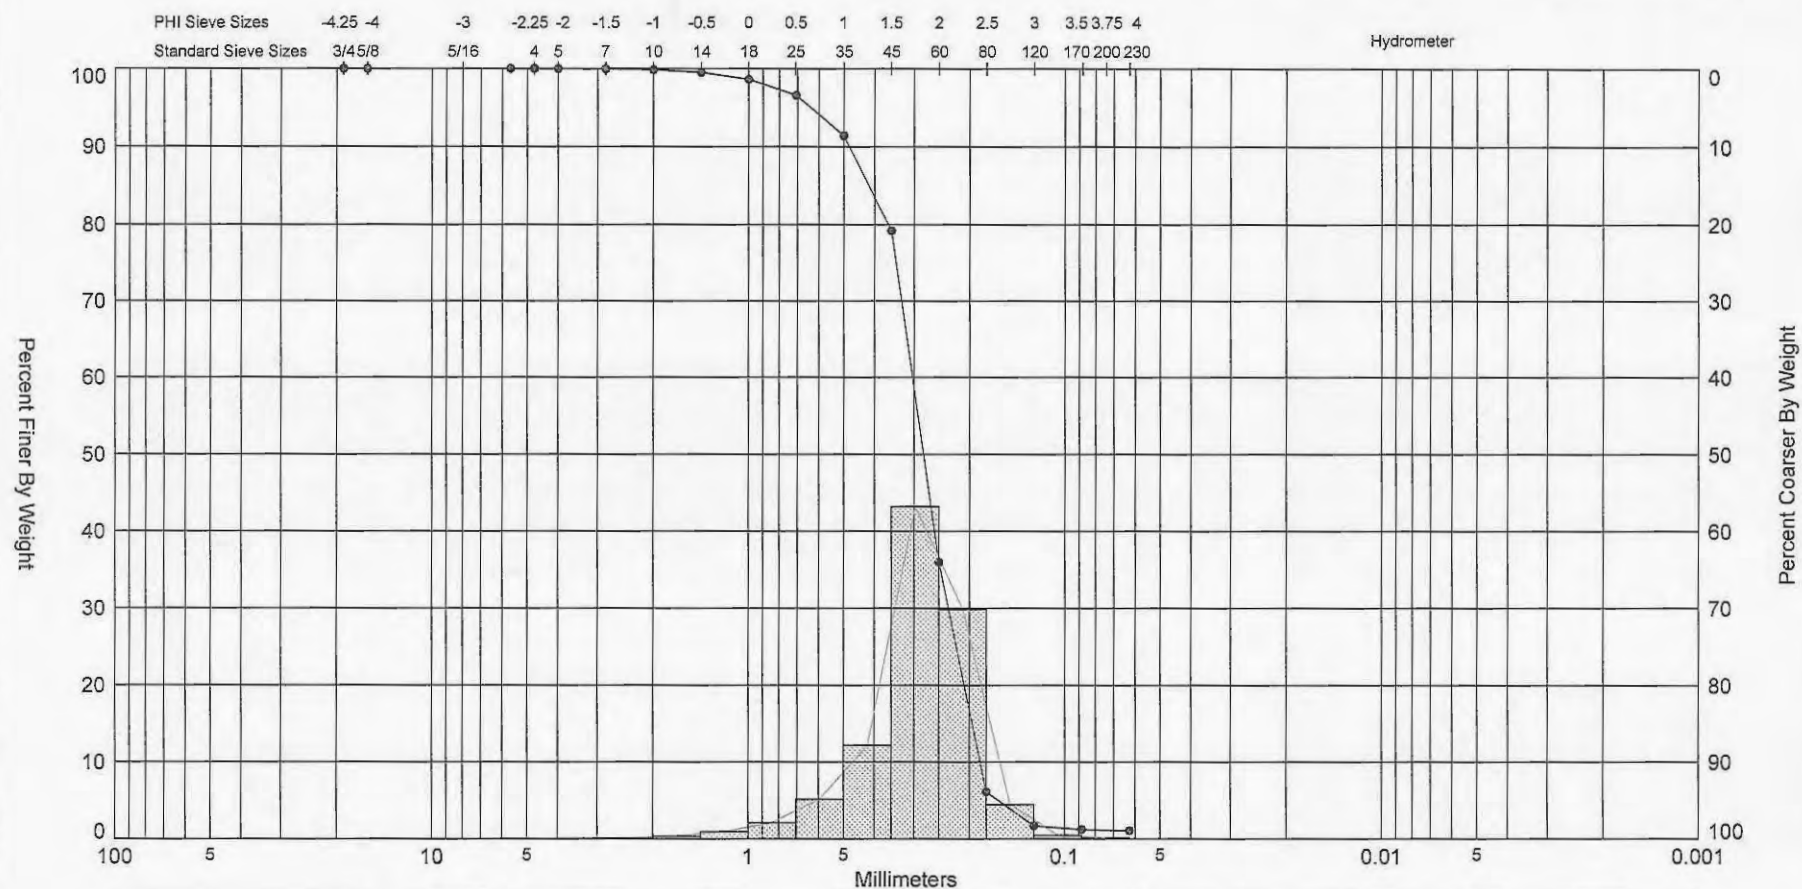
Gravel		Sand			Silt and Clay
Coarse	Fine	Coarse	Medium	Fine

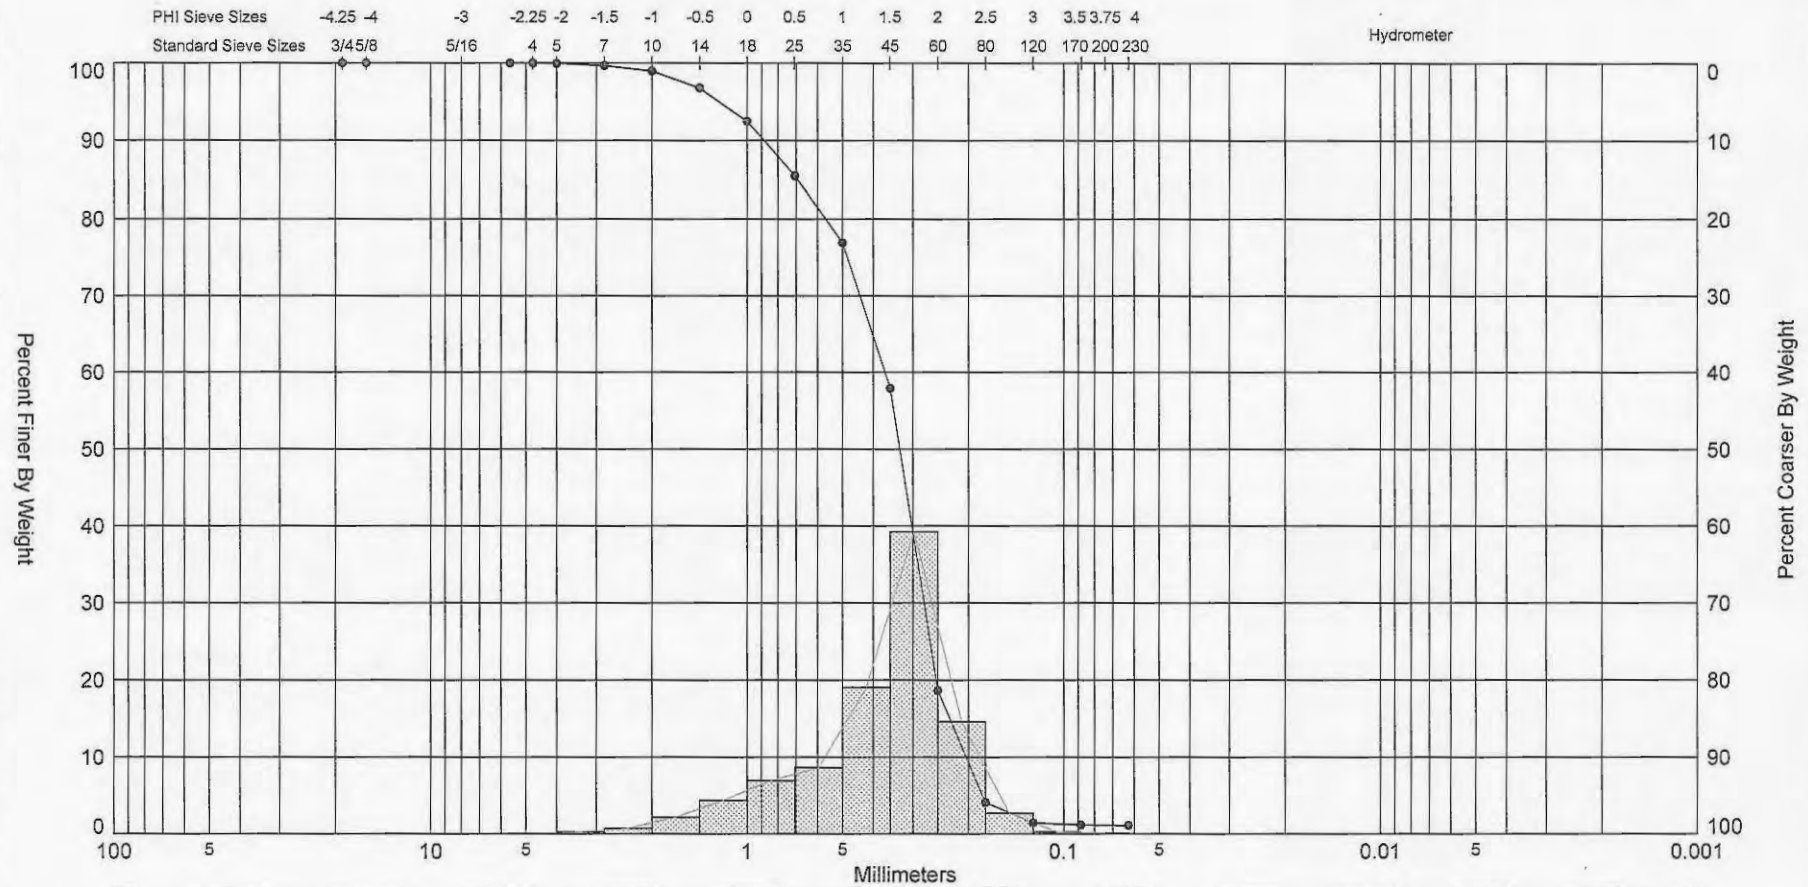
Gravel		Sand			Silt and Clay
Coarse	Fine	Coarse	Medium	Fine

Sample	Symbol	Elev. (ft)	USCS	% Fines	% Organics	% Carbonates	Median	Mean	Skew	Kurt	Sort	Sample Information	
JIVC-10-50 #S-2 (4')	—●—	-50.4	SP	#230 - 1.08			1.6	1.39	-1.08	4.29	0.81	Project Name:	Jupiter Island 10 Detail Phase
Comments: Visual Shell Content = 0%												Analysis Date:	11-16-10
Depths and elevations based on measured values												Analyzed By:	CA
<div style="display: flex; align-items: center;"> <div> <p>American Vibracore Services, Inc.</p> <p>1215 Wallace Drive</p> <p>Delray Beach, FL 33444</p> </div> </div>												Easting (X, ft):	968726.
												Northing (Y, ft):	978358.
												Horizontal System:	NAD 1983
												Vertical System:	NAVD 88

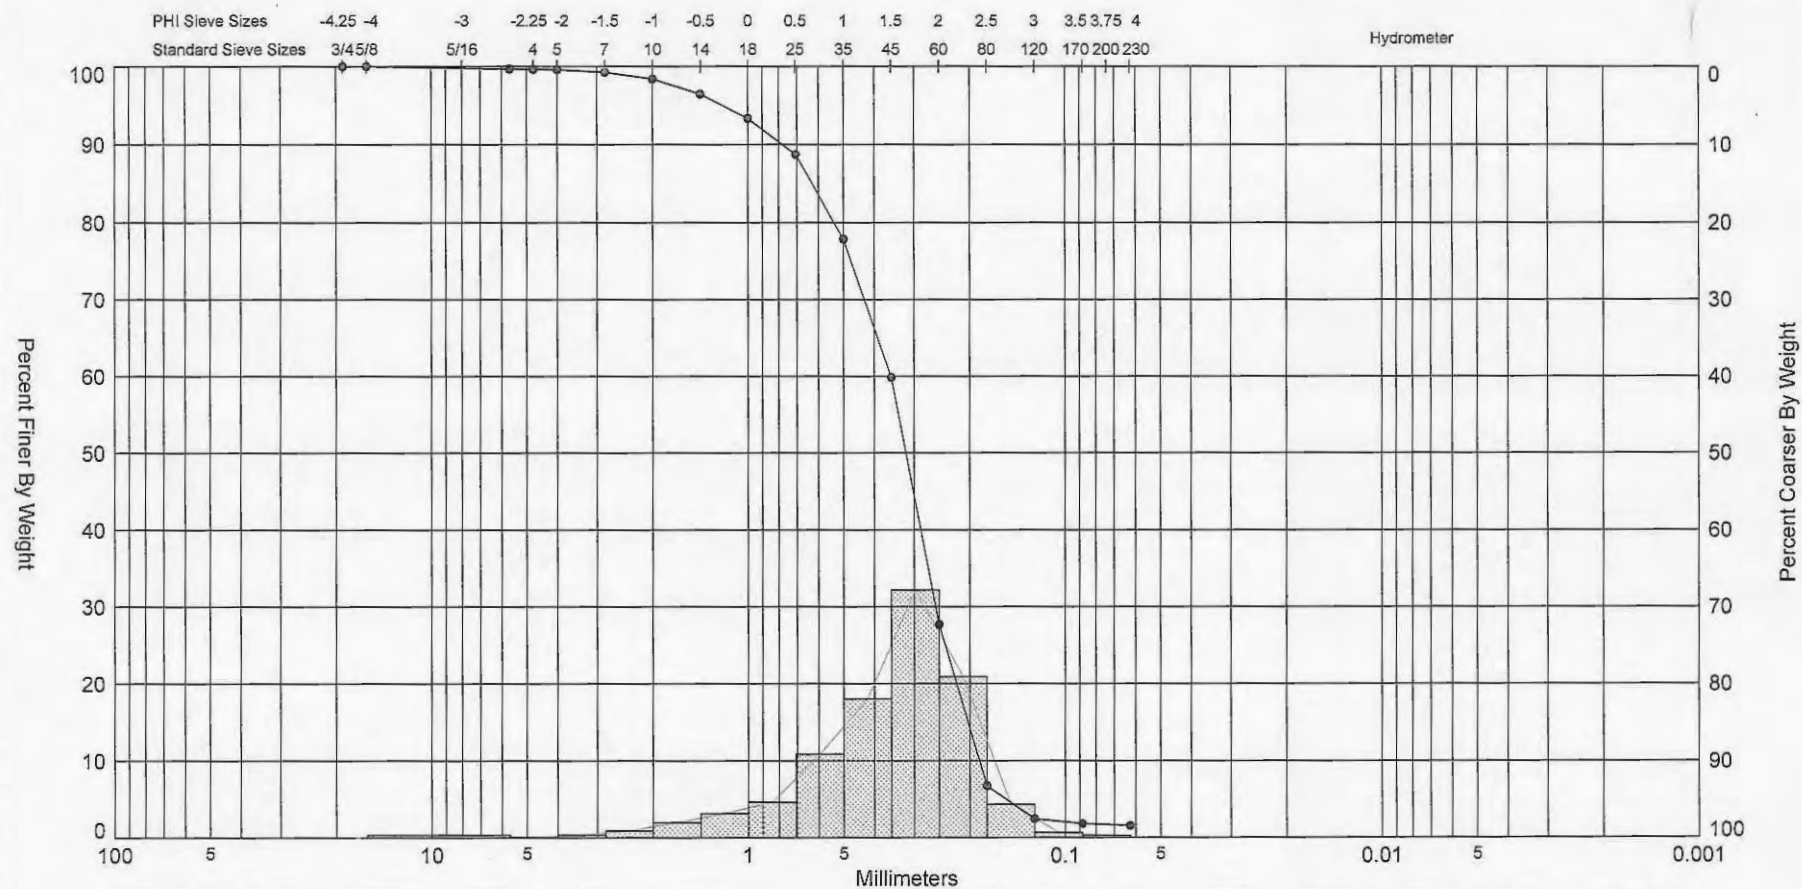
Gravel		Sand			Silt and Clay
Coarse	Fine	Coarse	Medium	Fine

Sample	Symbol	Elev. (ft)	USCS	% Fines	% Organics	% Carbonates	Median	Mean	Skew	Kurt	Sort	Sample Information	
JIVC-10-50 #S-3 (7')	—●—	-53.4	SW	#230 - 1.53		68.90	1.65	1.47	-1.36	6.47	0.88	Project Name:	Jupiter Island 10 Detail Phase
Comments: Visual Shell Content = >1%												Analysis Date:	11-09-10
Depths and elevations based on measured values												Analyzed By:	JR

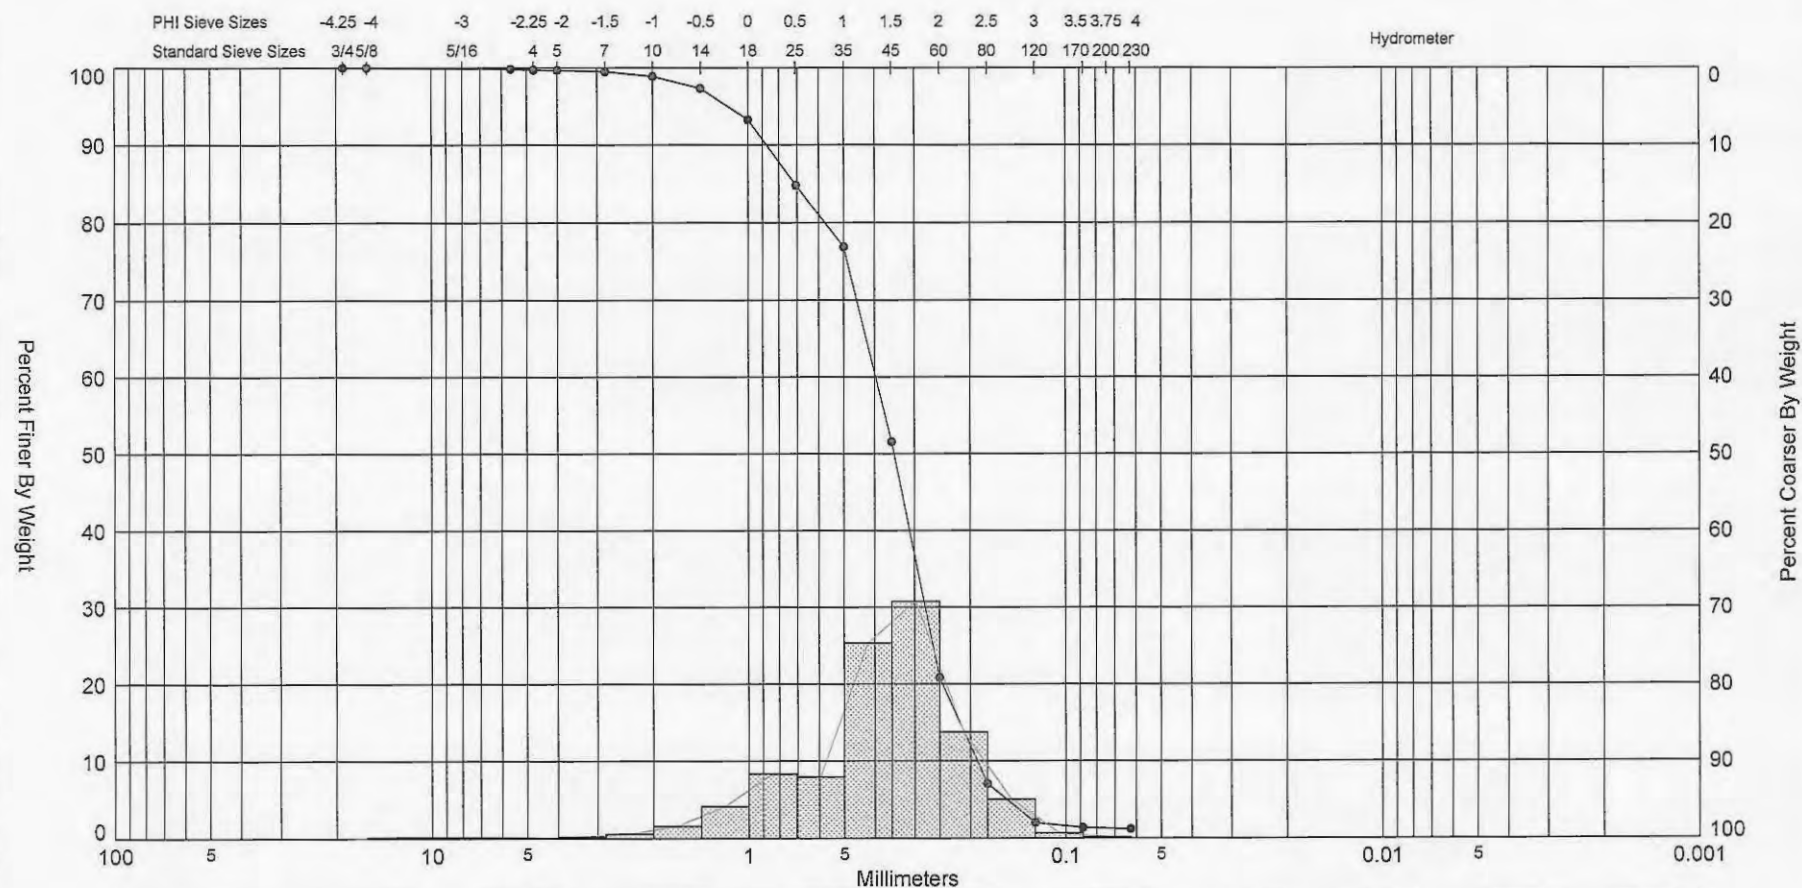
Gravel		Sand			Silt and Clay
Coarse	Fine	Coarse	Medium	Fine

Sample	Symbol	Elev. (ft)	USCS	% Fines	% Organics	% Carbonates	Median	Mean	Skew	Kurt	Sort	Sample Information	
JIVC-10-50 #S-4 (10')	—●—	-56.4	SP	#230 - 1.18			1.53	1.39	-0.97	5.2	0.85	Project Name:	Jupiter Island 10 Detail Phase
Comments: Visual Shell Content = >1%												Analysis Date:	11-17-10
Depths and elevations based on measured values												Analyzed By:	CA
