Sample	Symbol	Elev. (ft)	USCS	% Fines	% Organics	% Carbonates	Median	Mean	Skew	Kurt	Sort	Sample Information	
JIVC-10-52 #S-1 (1')	—●—	-49.6	SP	#230 - 1.20			1.13	1.01	-0.96	5.8	0.76	Project Name:	Jupiter Island 10 Detail Phase
Comments: Visual Shell Content = 0%												Analysis Date:	11-17-10
Depths and elevations based on measured values												Analyzed By:	CA
<div style="display: flex; align-items: center;"> <div> <p>American Vibracore Services, Inc.</p> <p>1215 Wallace Drive</p> <p>Delray Beach, FL 33444</p> </div> </div>												Easting (X, ft):	968452.
												Northing (Y, ft):	979326.
												Horizontal System:	NAD 1983
												Vertical System:	NAVD 88

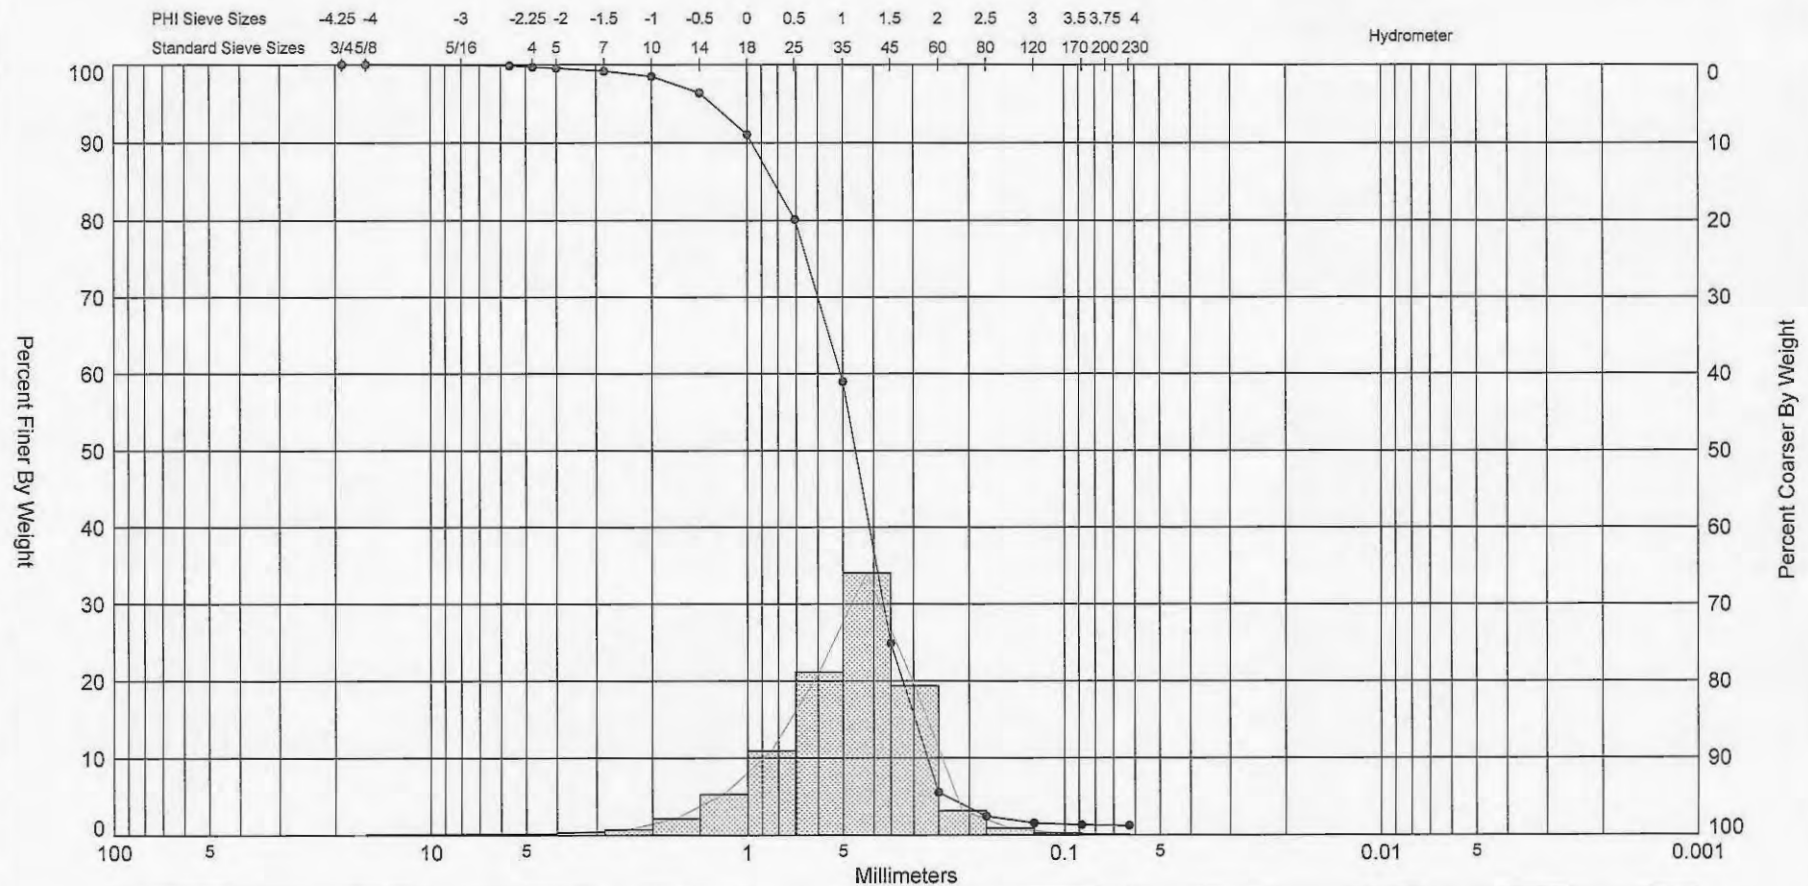
Gravel		Sand			Silt and Clay
Coarse	Fine	Coarse	Medium	Fine

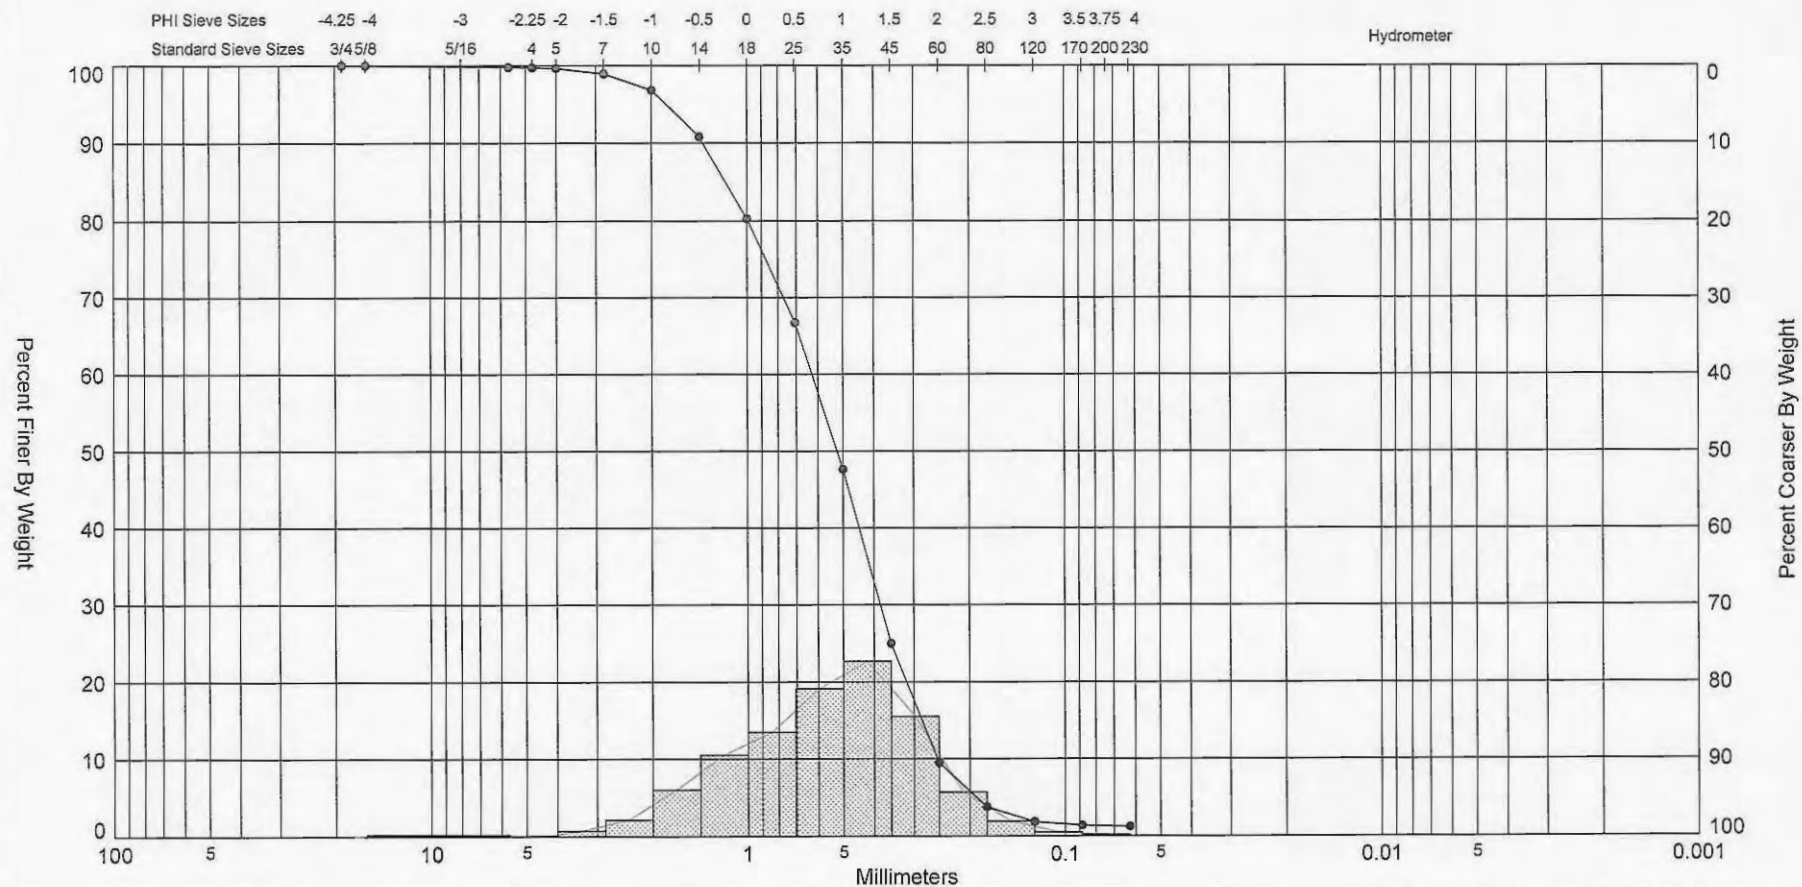
Gravel		Sand			Silt and Clay
Coarse	Fine	Coarse	Medium	Fine

Sample	Symbol	Elev. (ft)	USCS	% Fines	% Organics	% Carbonates	Median	Mean	Skew	Kurt	Sort	Sample Information	
JIVC-10-52 #S-2 (5')	—●—	-53.6	SW	#230 - 1.22		82.80	0.94	0.82	-0.39	3.42	0.96	Project Name:	Jupiter Island 10 Detail Phase
Comments: Visual Shell Content = >1%												Analysis Date:	11-30-10
Depths and elevations based on measured values												Analyzed By:	ML

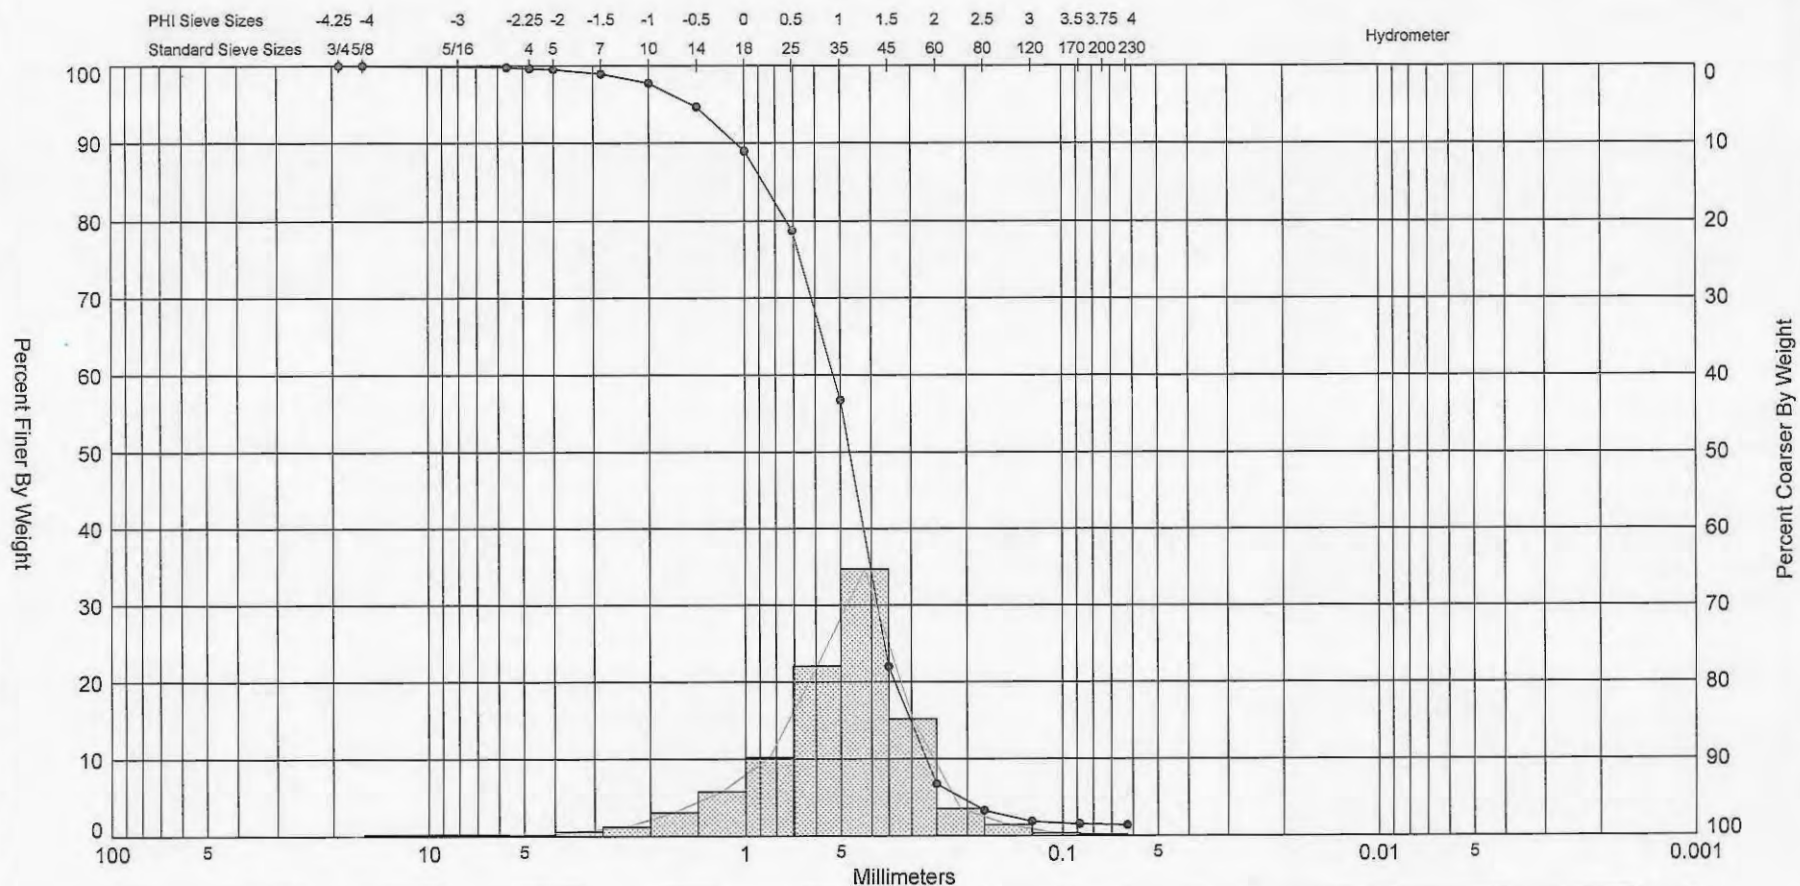
Gravel		Sand			Silt and Clay
Coarse	Fine	Coarse	Medium	Fine

Sample	Symbol	Elev. (ft)	USCS	% Fines	% Organics	% Carbonates	Median	Mean	Skew	Kurt	Sort	Sample Information	
JIVC-10-52 #S-3 (8')	—●—	-56.6	SP	#230 - 1.37			1.1	0.96	-0.9	5.62	0.82	Project Name:	Jupiter Island 10 Detail Phase
Comments: Visual Shell Content = >1%												Analysis Date:	11-17-10
Depths and elevations based on measured values												Analyzed By:	CA

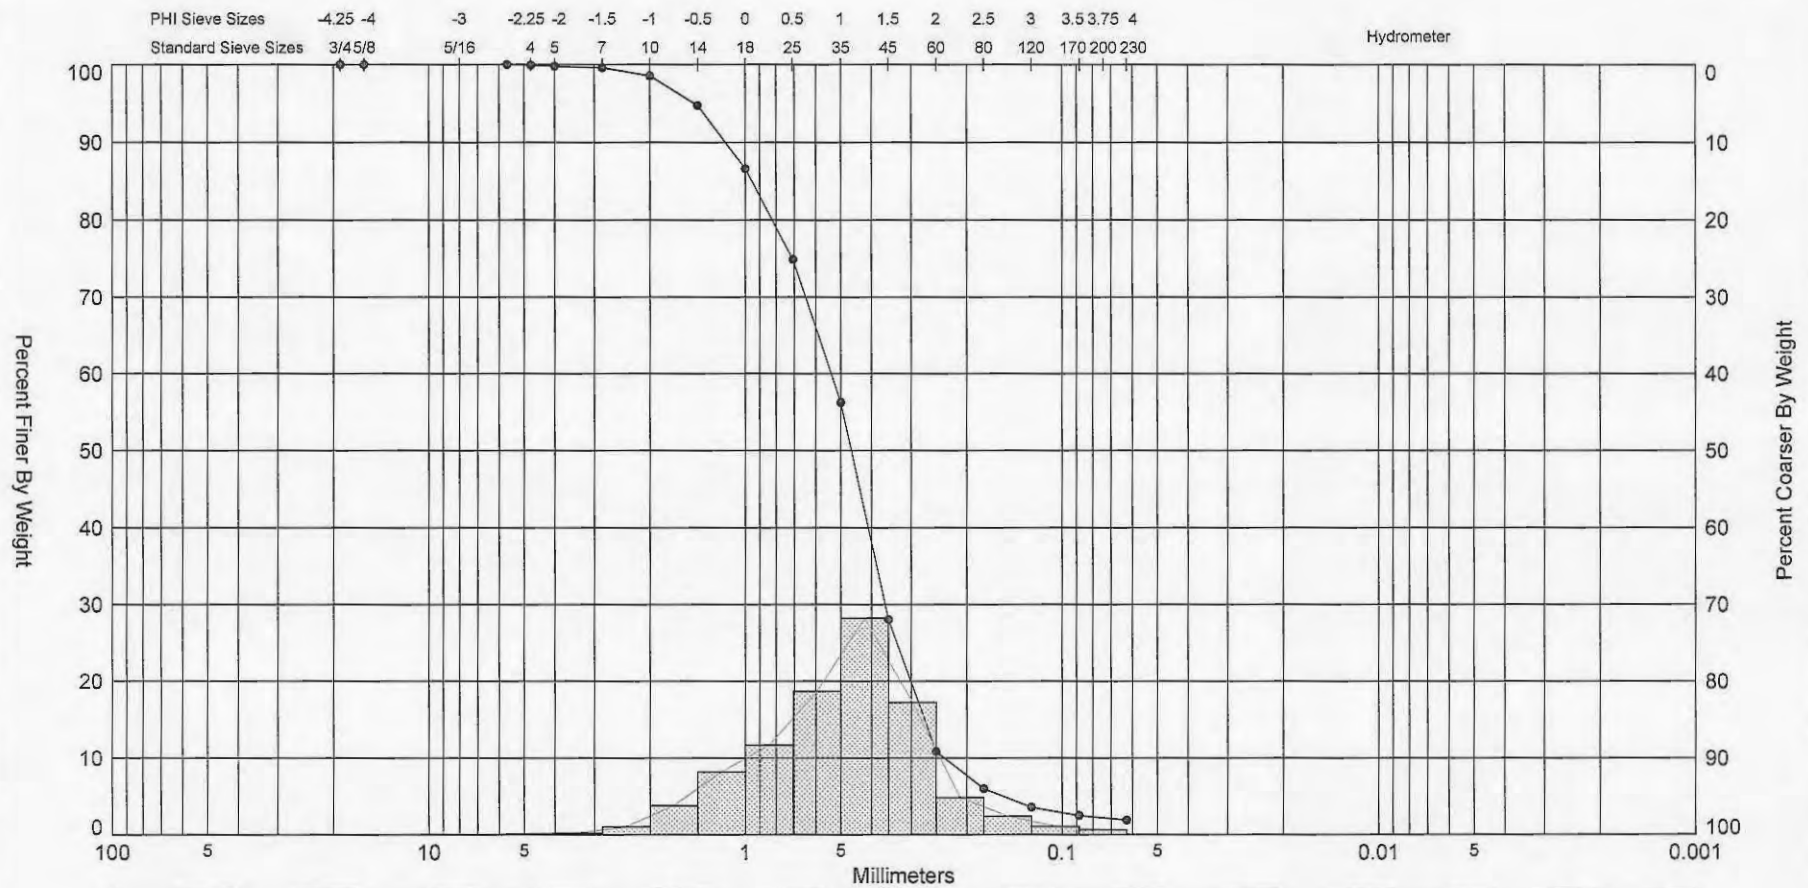
Gravel		Sand			Silt and Clay
Coarse	Fine	Coarse	Medium	Fine

Sample	Symbol	Elev. (ft)	USCS	% Fines	% Organics	% Carbonates	Median	Mean	Skew	Kurt	Sort	Sample Information	
JIVC-10-52 #S-4 (11')	—●—	-59.6	SW	#230 - 1.91		84.00	1.11	1	-0.16	3.65	0.89	Project Name:	Jupiter Island 10 Detail Phase
Comments: Visual Shell Content = 0%												Analysis Date:	11-11-10
Depths and elevations based on measured values												Analyzed By:	JR
