Sample	Symbol	Elev. (ft)	USCS	% Fines	% Organics	% Carbonates	Median	Mean	Skew	Kurt	Sort	Sample Information	
JIVC-10-30 #S-1 (1')	—●—	-53.2	SW	#230 - 2.17			1.12	0.96	-0.36	2.49	0.98	Project Name:	Jupiter Island 10 Detail Phase
Comments: Visual Shell Content = >1%												Analysis Date:	11-16-10
Depths and elevations based on measured values												Analyzed By:	CA

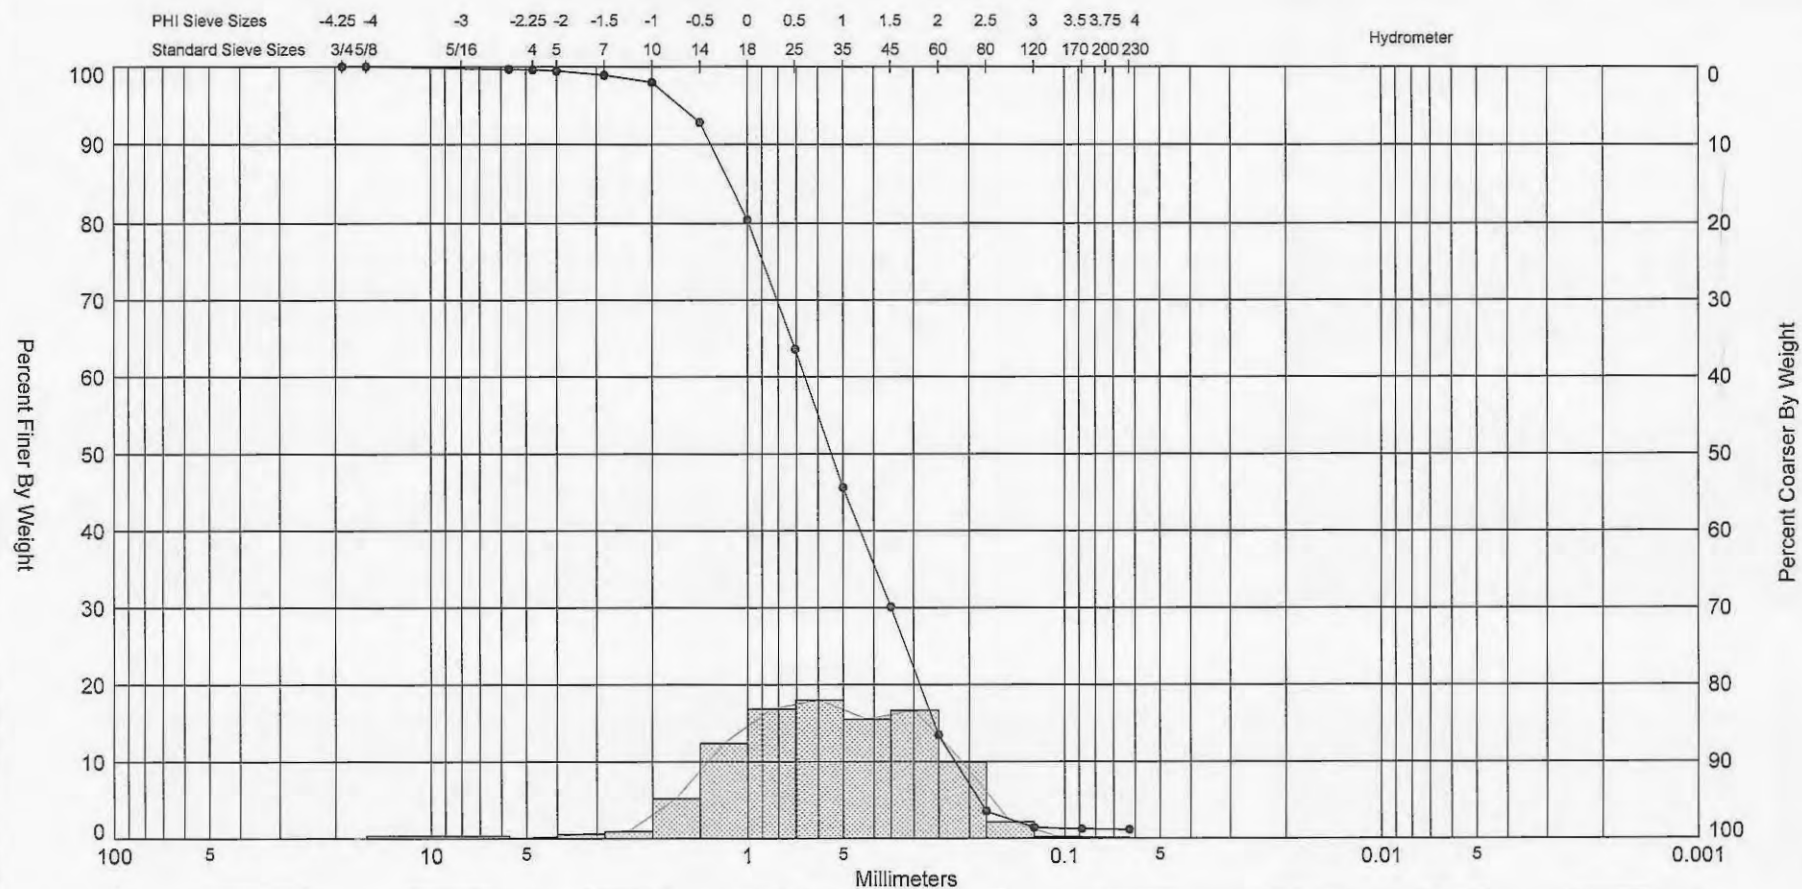
Gravel		Sand			Silt and Clay
Coarse	Fine	Coarse	Medium	Fine

Sample	Symbol	Elev. (ft)	USCS	% Fines	% Organics	% Carbonates	Median	Mean	Skew	Kurt	Sort	Sample Information	
JIVC-10-30 #S-2 (5')	—●—	-57.2	SW	#230 - 1.12		81.00	0.88	0.86	-0.33	3.3	0.98	Project Name:	Jupiter Island 10 Detail Phase
Comments: Visual Shell Content = >1%												Analysis Date:	11-30-10
Depths and elevations based on measured values												Analyzed By:	ML

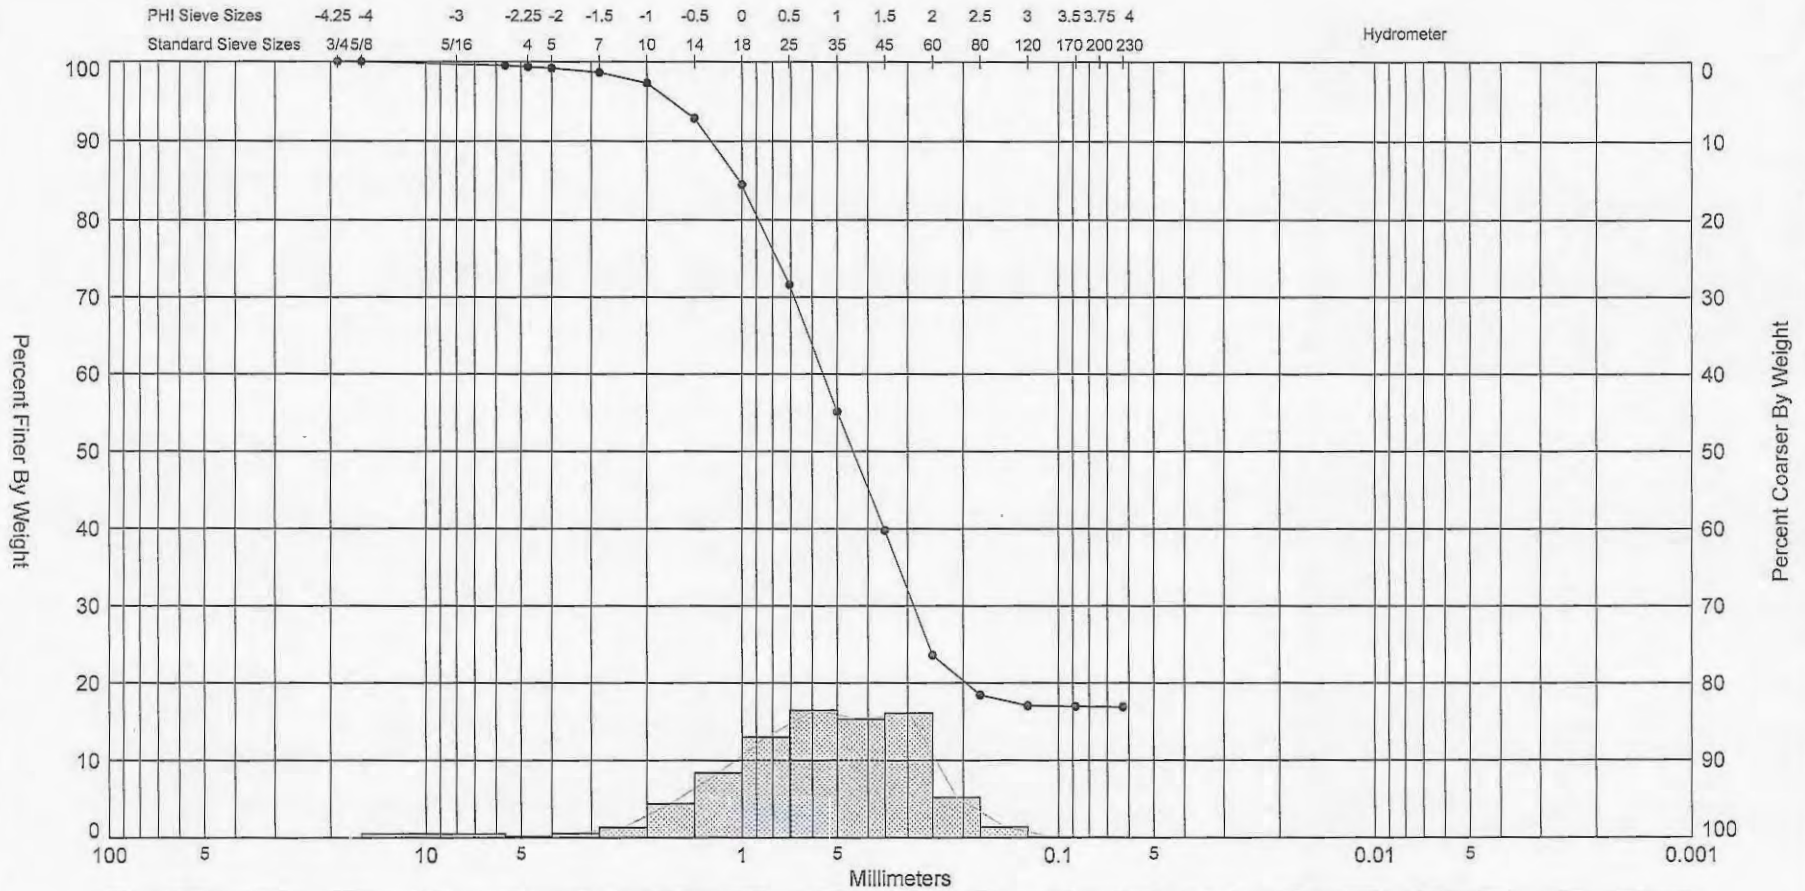
Gravel		Sand			Silt and Clay
Coarse	Fine	Coarse	Medium	Fine

Sample	Symbol	Elev. (ft)	USCS	% Fines	% Organics	% Carbonates	Median	Mean	Skew	Kurt	Sort	Sample Information	
JIVC-10-30 #S-3 (9')	—●—	-61.2	SM-SC	#230 - 16.93			1.17	0.83	-0.69	4.19	0.97	Project Name:	Jupiter Island 10 Detail Phase
Comments: Visual Shell Content = 1%												Analysis Date:	11-18-10
Depths and elevations based on measured values												Analyzed By:	CA

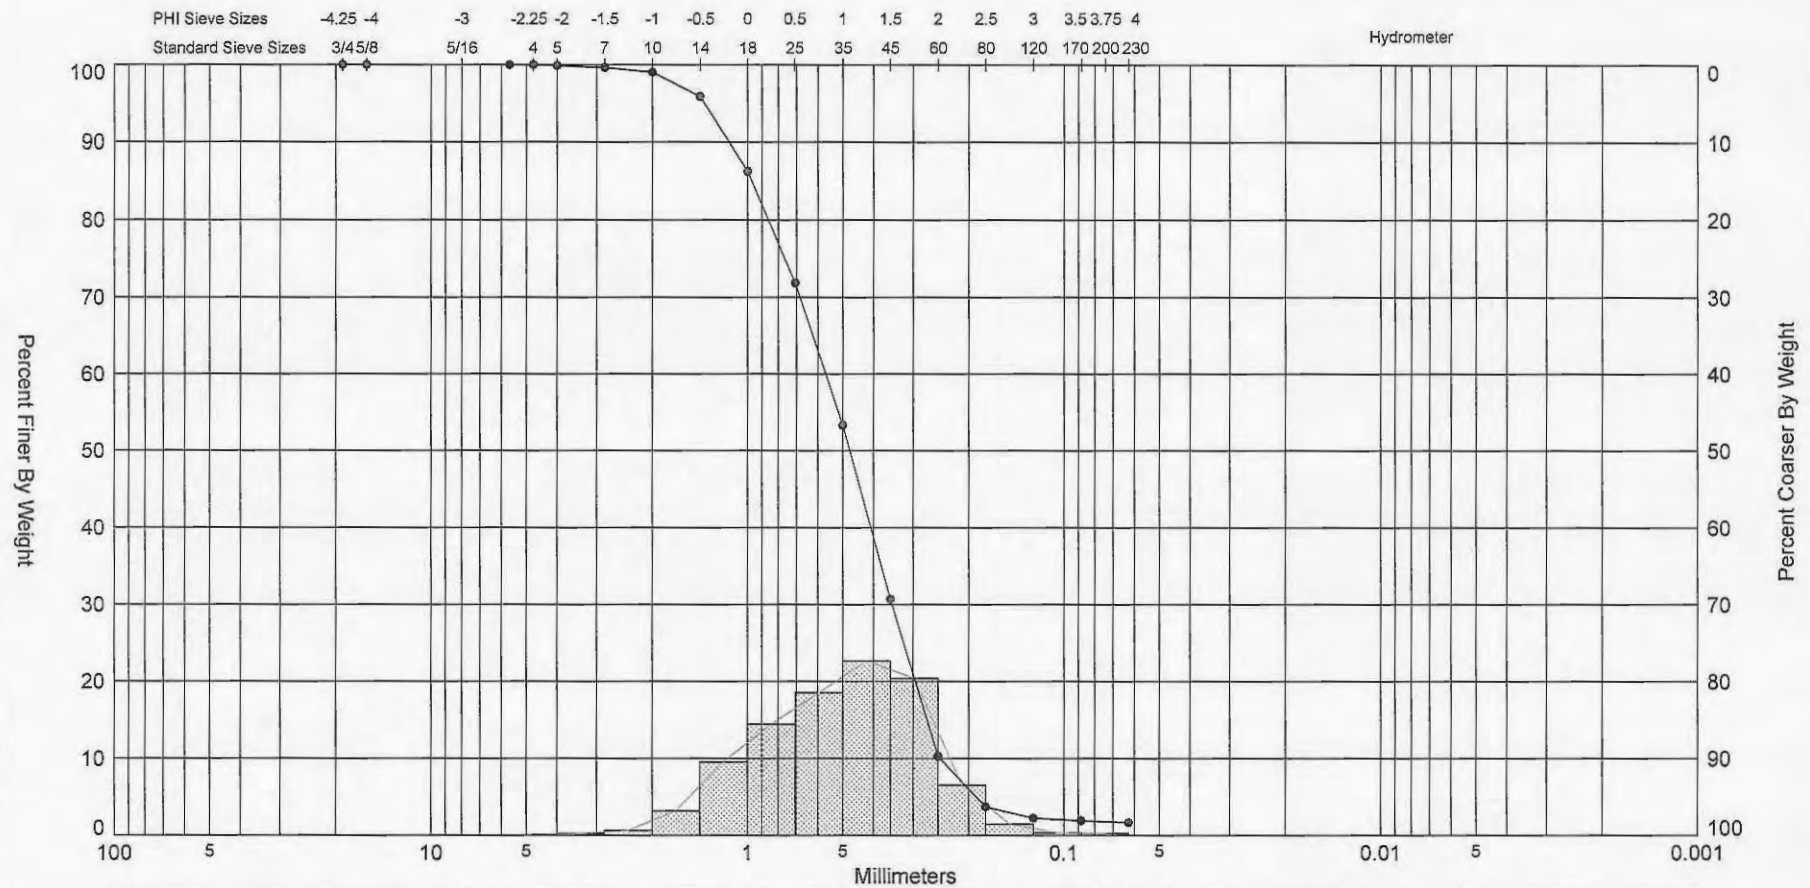
Gravel		Sand			Silt and Clay
Coarse	Fine	Coarse	Medium	Fine

Sample	Symbol	Elev. (ft)	USCS	% Fines	% Organics	% Carbonates	Median	Mean	Skew	Kurt	Sort	Sample Information	
JIVC-10-30 #S-4 (12')	—●—	-64.2	SP	#230 - 1.67		78.50	1.07	0.98	-0.24	3.03	0.85	Project Name:	Jupiter Island 10 Detail Phase
Comments: Visual Shell Content = 0%												Analysis Date:	11-09-10
Depths and elevations based on measured values												Analyzed By:	JR
<div style="display: flex; align-items: center;"> <div style="flex: 1; text-align: center;">
