-23.7		SP	#200 - 0.61 #230 - 0.23	3.13	3.02	-3.31	18.29	0.52	Project Name:	Palm Beach County Vibracore 2004
											Analysis Date:	07-01-04
											Analyzed By:	SEA Inc.
Scientific Environmental Applications, Inc. 5575 Willoughby Drive Melbourne, FL 32934 (321) 254-2708 Seapp1@aol.com											Easting (X):	972,048
											Northing (Y):	905,419
											Horizontal System:	NAD 1983
											Vertical System:	NAVD 29

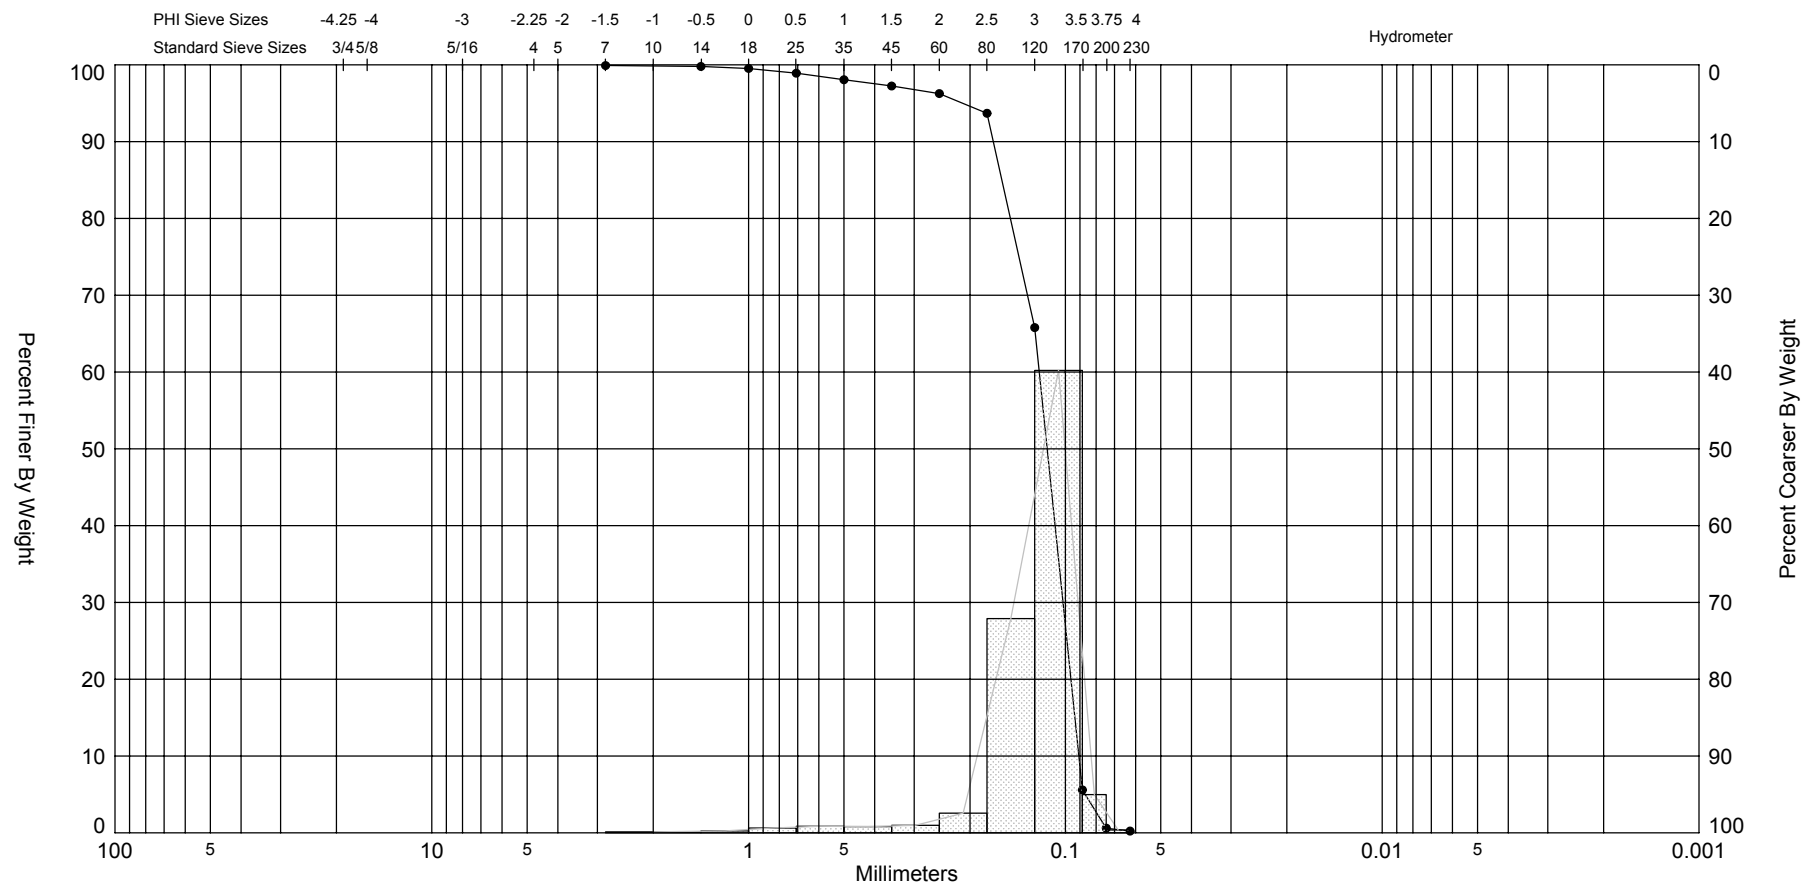
Gravel		Sand			Silt and Clay
Coarse	Fine	Coarse	Medium	Fine

Sample	Symbol	Elev.	Comments	USCS	% Fines	Median	Mean	Skew	Kurt	Sort	Sample Information	
SI04-4 #1.0

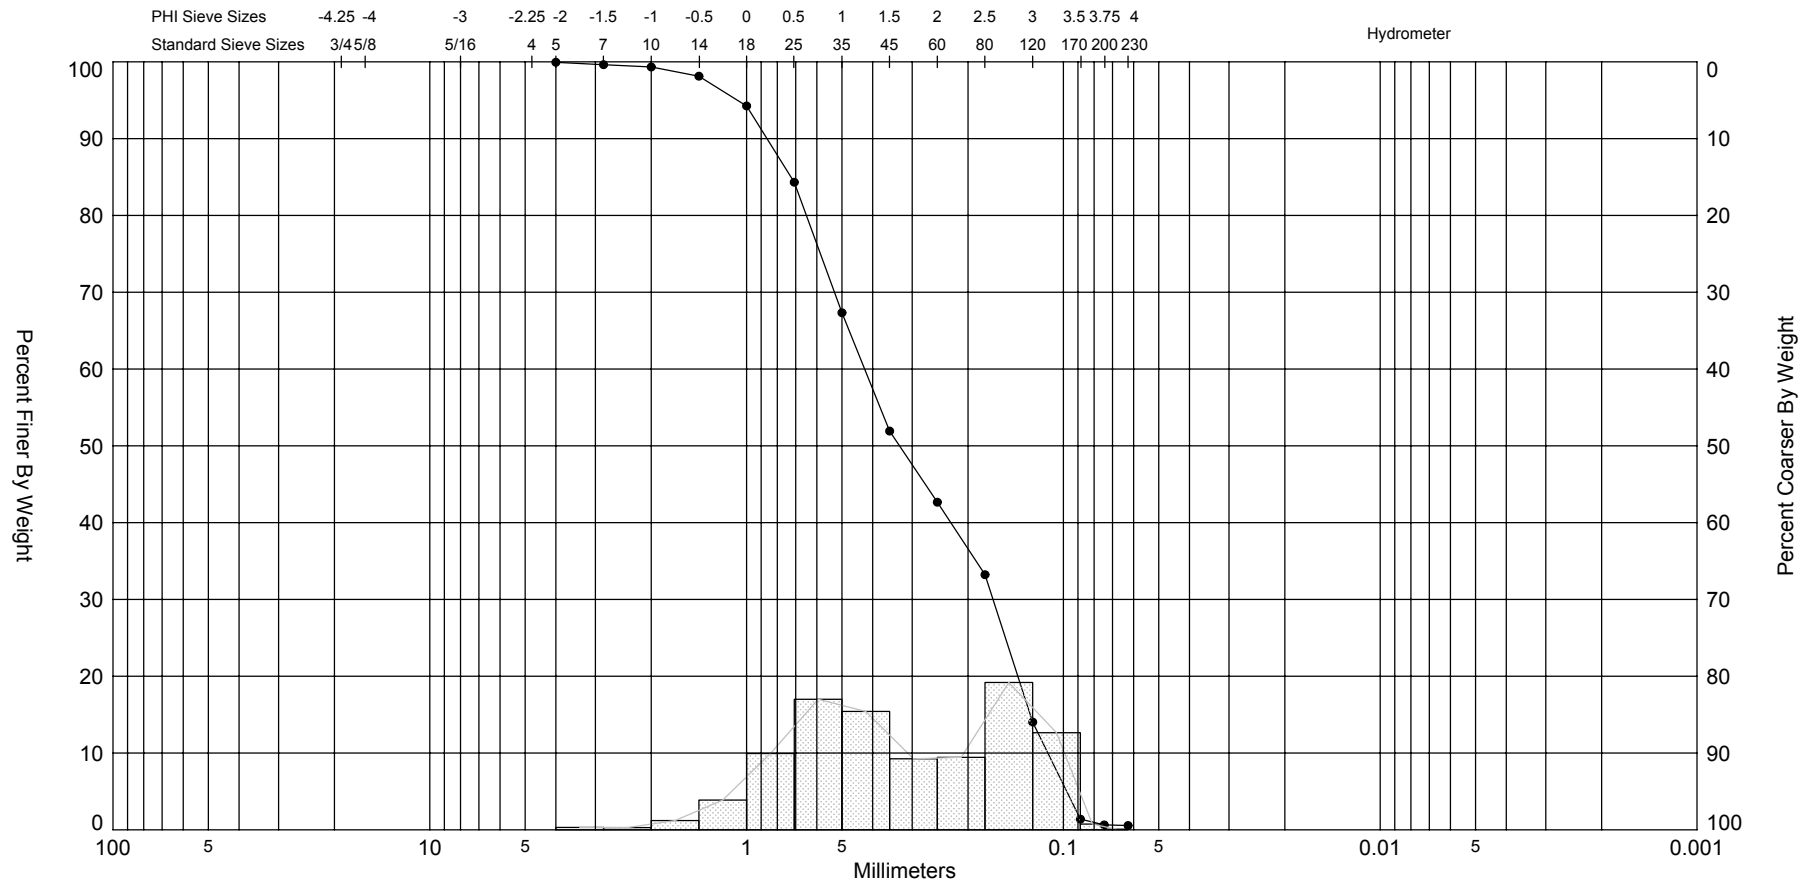
Gravel		Sand			Silt and Clay
Coarse	Fine	Coarse	Medium	Fine

Sample	Symbol	Elev.	Comments	USCS	% Fines	Median	Mean	Skew	Kurt	Sort	Sample Information	
SI04-4 #11.0	—●—	-33.7		SP	#200 - 0.64 #230 - 0.56	1.6	1.67	-0.18	2.09	1.12	Project Name:	Palm Beach County Vibracore 2004
											Analysis Date:	07-01-04
											Analyzed By:	SEA Inc.
Scientific Environmental Applications, Inc. 5575 Willoughby Drive Melbourne, FL 32934 (321) 254-2708 Seapp1@aol.com											Easting (X):	972,048
											Northing (Y):	905,419
											Horizontal System:	NAD 1983
											Vertical System:	NAVD 29
